Proposed Staged Upgrade for Karratha Works Depot

Existing Conditions, Future Operational Needs and Compliance
Assessment

March 2015

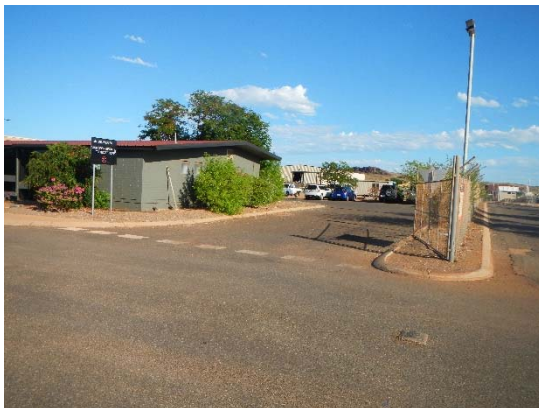
Entry Gate Signage

The administration area is currently located to the rear of the building well away from the entry gate. Even with signage, visitors to the Depot regularly wander randomly through the outer yard and building until they find someone to direct them to the Depot reception area.

This access area has been relocated associated with the 2013 Administration building renovations, but access is still not ideal with visitors entering the Depot internal car park area and disability provisions require some further improvements. External parking is recommended with controlled access into a new administration reception area associated with any new building developments.

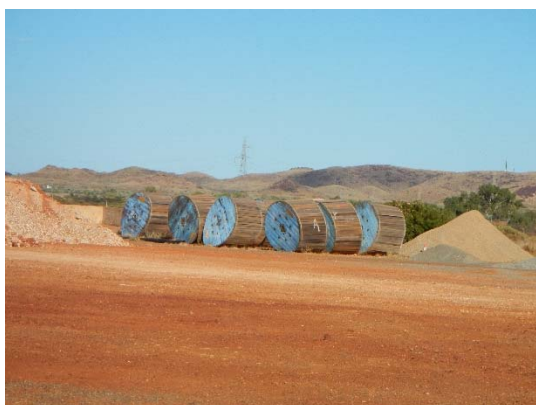
Cable Drums

Additionally within this area a number of electrical cables in drums have been stored. The cable containers are deteriorating and require maintenance to enable relocation in the future. Future usage needs for the cable should be evaluated and if required to be retained, relocated to a more remote section of the Depot where they will not interfere with ongoing operational storage access.

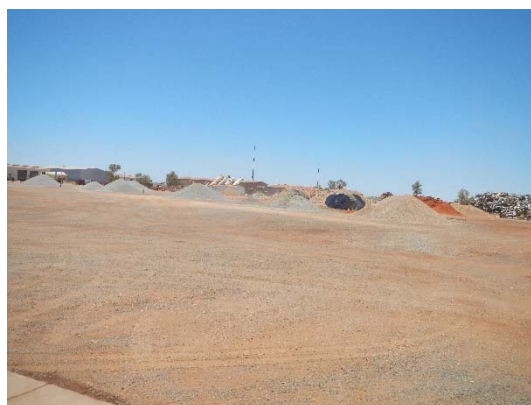
Materials Storage Area

Four storage bins are located at the rear of the Depot used for storing cold asphalt, fine graded stone, medium graded stone and clean sand. At present these bins are empty due to issues with contamination from the nearby non stabilised surrounds. In addition there are random stockpiles of Parks materials located around the Depot comprising garden mulch, rounded river stones, large graded stone, road base, rock and top soil.

To assist with reduced contamination of stored materials simple shade cloth coverings or the installation of a simplified spray reticulation system could be installed to suppress dust. Also surrounding areas could be replaced with compacted gravel pavement. The water supply could be sourced from the planned improved recycled treated water from the proposed upgraded heavy plant and vehicle wash down bay area. Additionally the need for the storage bins should be discussed with the Works and Parks Departments as some materials currently stored on site may be more effectively delivered directly to work sites from suppliers.

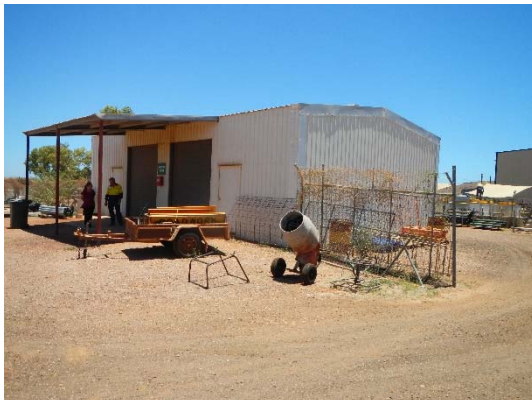
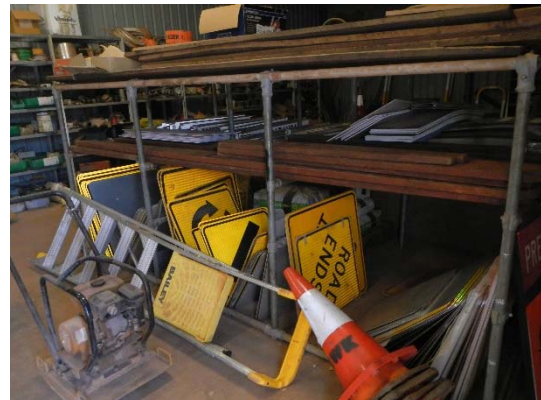
Works Shed Exterior

Works storage of materials and equipment is also spread over a number of locations around the Depot. A shed for minor equipment with associated works signage is located on the northern side of the workshop area. Pipes, drainage components, bridge components and the bitumen storage areas are spread over the current site. Additionally some specialist signage has been located in a dilapidated transportable which is not considered effective or safe.

It is recommended that a new shed be located on the south side of the site that can cater for both Works minor plant and signs with associated circulating vehicle areas for accessing

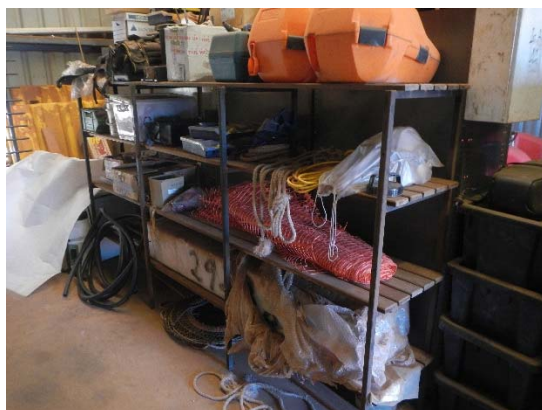
Parks and Gardens Storage

Parks and Gardens storage of materials and equipment is similarly spread over a number of locations and sheds around the Depot. Any derelict plant items taking up space in the Depot should be disposed of in accordance with the appropriate City processes.

4. Consideration should be made for a dedicated, lockable open front shed to enable Parks to store their mowers. Currently all equipment is left in the open sun, and as such the plastics and seating quickly degrade, increasing maintenance costs. This can be located to the rear of the current shed, within the Parks yard.

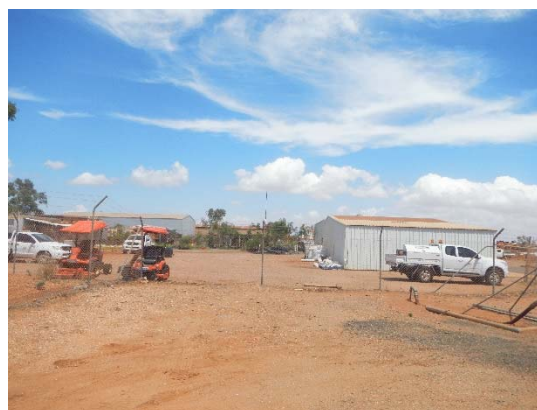
Parks Shed and Yard

There is currently ample space for Parks and Gardens to be able to store and secure their light vehicles and trailers in the general yard area opposite and at the rear of the existing Parks sheds.

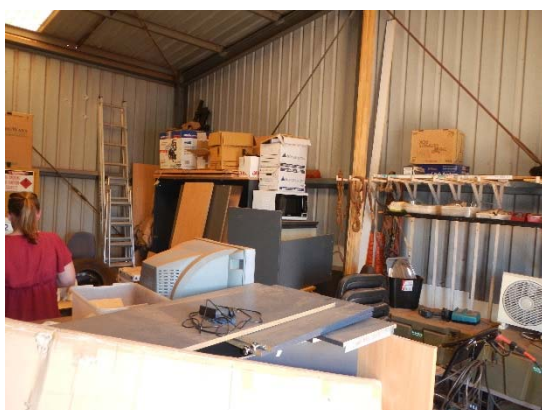
BM Section of Shed (Old Furniture)

Generally this section of the shed needs an internal tidy with installation of racking and unwanted materials disposed of per City procedures. If other sheds were available then the Building Maintenance section could relocate enabling the EHO vehicle to be housed for security.

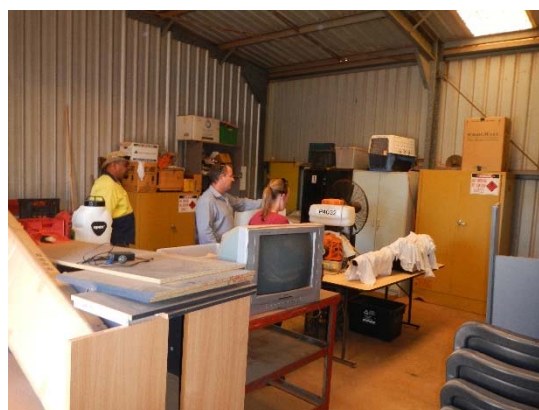
EH Chemical Section of Shed

The southern section of the shed adjacent to the Parks shed is partly utilised by the Building Maintenance (Handy Person) and Environmental Health (Mosquito Control) Department operations. As this portion of the shed is used to store chemicals an evaluation is recommended to consider if all site chemicals should be located in a common area for improved security and climate control.

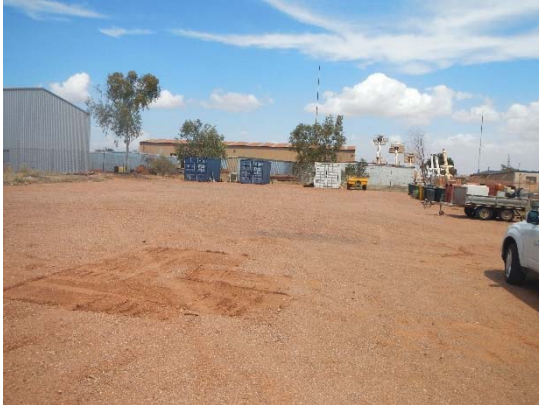
Open Storage Fenced Yard

The majority of this area is available for other storage and could have another gate access created at the southern end to allow an in and out vehicle access with lockable gates if the impounded vehicles were to be relocated in this area.

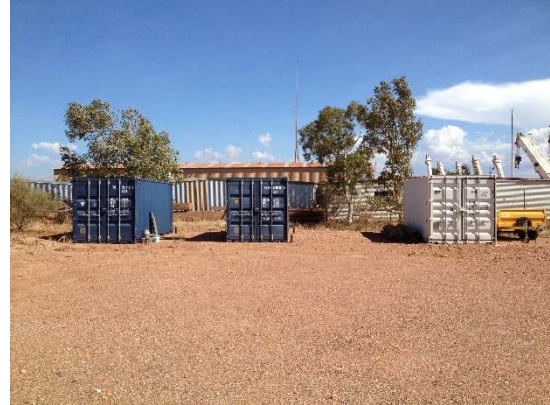
Sea Containers Used for Storage

Another container is also located in this area and is utilised by the Facilities Events Team for storage of events equipment. It is noted however that some items of value are being stored outside of the containers, and therefore it is recommended that additional containers be purchased to house these items.

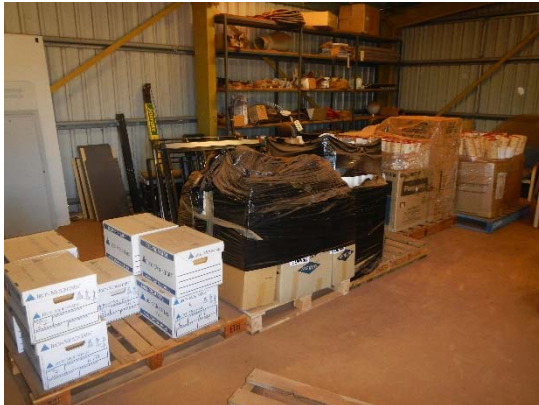
Stored Documents and Plans

There is a shed used for the storage of furniture and plans. This shed is essentially full however much of the furniture located in the shed is past its use by date and is occupying valuable space. A disposal process needs to be developed and implemented to manage the contents of this shed. The plans if having value could be scanned and digitised for effective future ease of reference and hard copies stored in an appropriate records storage facility.

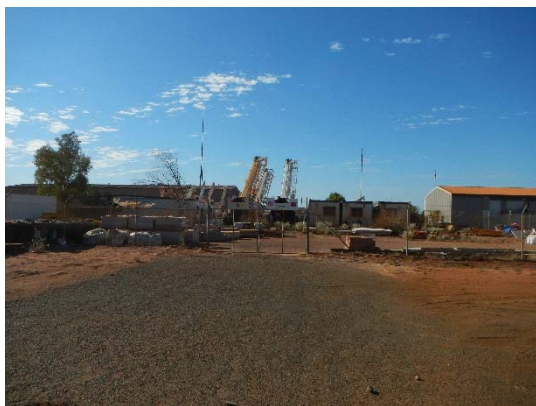
South Side Yard Stored Pavers

A fenced area currently exists where spare paving or second hand recreational sporting fields and playground equipment have been stored. The surplus paving should be assessed if paving types are still required. If so then store and / or stack neatly for ease of access and if not dispose of in accordance with City processes. Similarly with other stored equipment if surplus to needs or no longer safety compliant then dispose of per City processes or stack neatly and clearly label for future planned use.

Materials generally stored in this area is on a short term basis associated with waiting for installation by Contractors. It is suggested that the area remain and be managed through the Depot Facilities Team by registering stored goods for improved security and controls. A number of facilities items located on the northern side of the depot should also be relocated to this area.

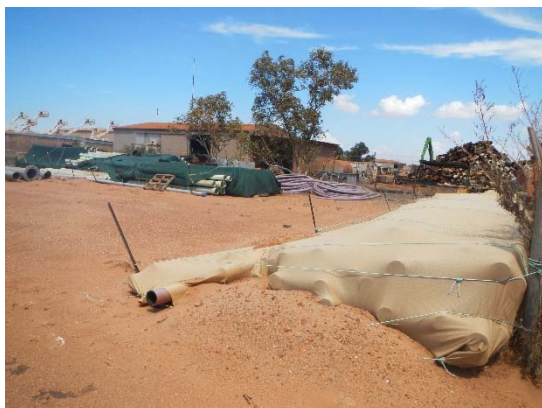
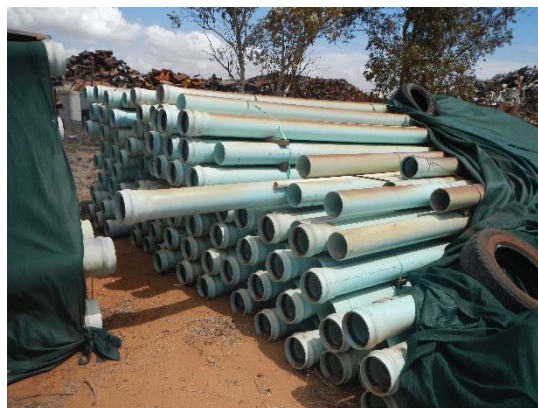
Large Stockpile HP Pipes

A large stockpile of HP poly pipes of various sizes and usage classifications have been stacked and covered in this area. The pipes were planned for use in the Effluent Reuse Scheme upgrade project. Suitability of use of the pipes for this project needs to be determined. If not usable then options for alternative uses or disposal should be considered to free up the space in the short term.

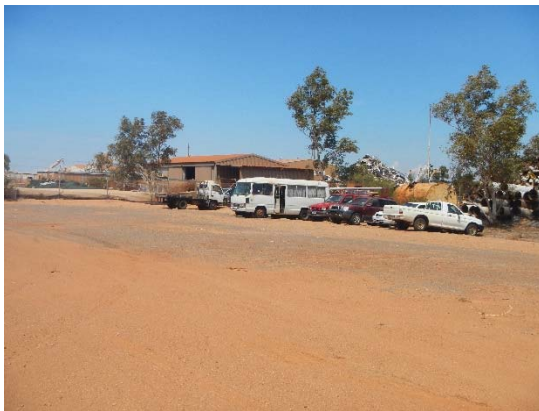
Vehicle Pound Area

Currently an area is allocated east of the animal pound areas for storage of impounded vehicles. The area set aside appears to be more than adequate as long as there is a disposal process in place and strictly implemented. A disposal process will assist in the effective timely removal of impounded vehicles.

The current location has been accessed illegally on a number of past occasions. It is suggested to relocate the impounded vehicles into an area with some associated rear of adjoining property passive surveillance, on the eastern side near the chicken coop. The area may require some additional fencing and another access gate for improved through access and security.

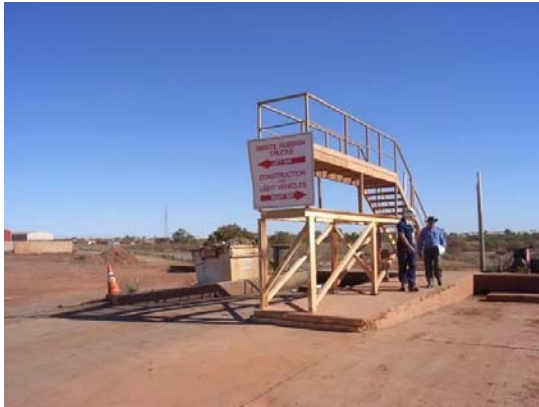
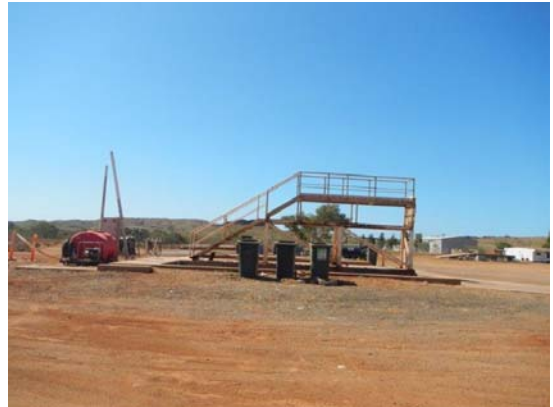
Non-Compliant Truck Wash Walkway

As part of the previous GHD study it was detailed that the existing vehicle and plant wash down bay was not an acceptable facility and should be replaced with one that provides improved compliant treatment and recovery / disposal of the used water, plus has the ability to cater for access of longer / wider plant items.

Current detailed design of this new facility is being progressed as part of the Stage 2 redevelopment.

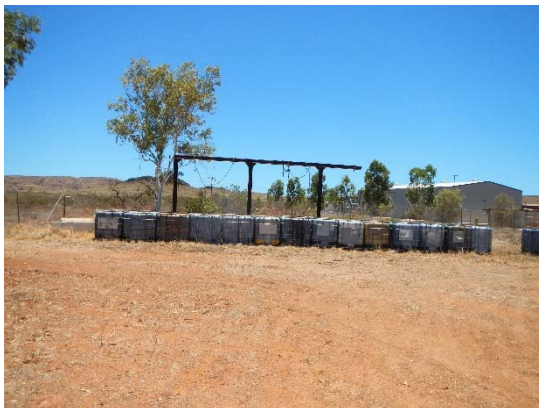
Gantry and Containers

This gantry area should have surplus materials and containers currently located near the site removed and disposed of per City processes. The area should be kept clear for use in loading and storage of large structural components.

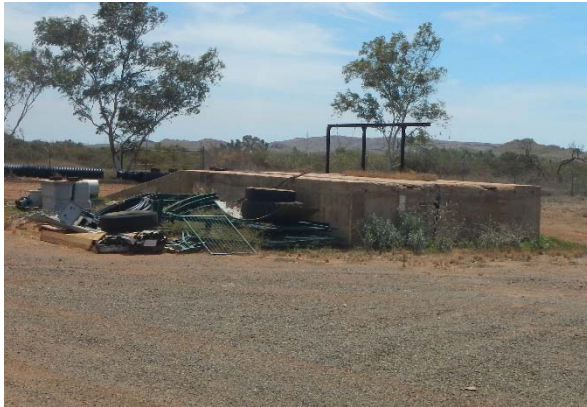
Loading Ramp

The loading ramp is well constructed and requires some minor repairs. It is recommended that the vehicle loading side has bitumen surfacing to ensure ease of access. The ramp is recommended to have hand rails installed to the sides and removable at the end to improve safe usage. Circulation clear space around the ramp needs to be maintained.

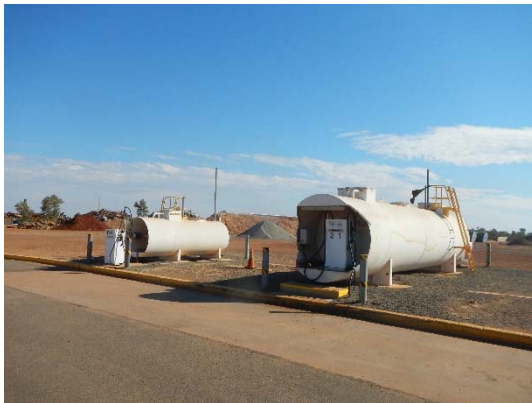
Fuel Pumps

Currently only bulk supplies of diesel is stored and distributed at the Depot. The current system for fuel storage and management has been reviewed to ensure the system meets current environmental, health and safety standards. As a result as part of the Stage 2 Works Depot Redevelopment it was resolved to implement an automated fuel management recording system for all bulk fuel storages located at all Depot sites. This system is currently being sourced through an RFQ process with funds allocated in 2014-15.

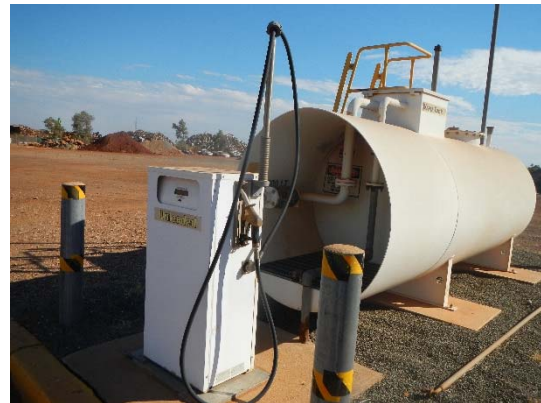
Fuel Pump to be Disposed

Additionally, there is a surplus 5,000L fuel tank in situ which has never been used as it did not meet Dangerous Goods requirements for the site. It is recommended that this tank be disposed of while it still has some saleable value, before the unit depreciates any further.

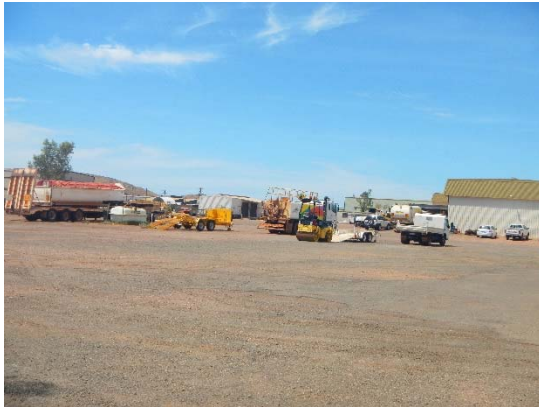
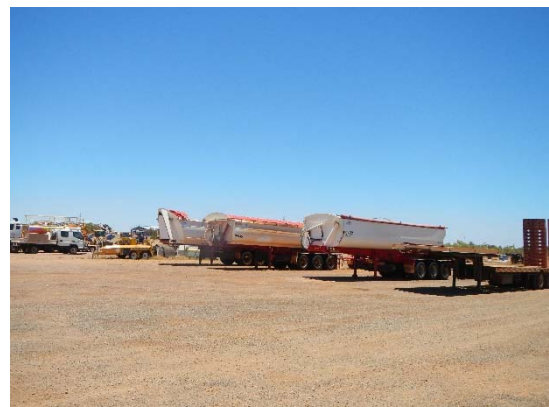
Plant and Equipment Parking Area

Currently all the large plant and equipment is parked in open gravelled storage areas to the west of the Workshop without any cover. The area should remain unsealed to allow movement of tracked heavy machines and turning of large heavy tyred plant that would only destroy any bitumen surfaced area.

Some covered parking may be considered in the future for occasional use specialised items of plant. The area may simply have a roof covering and part side covering with security gating.

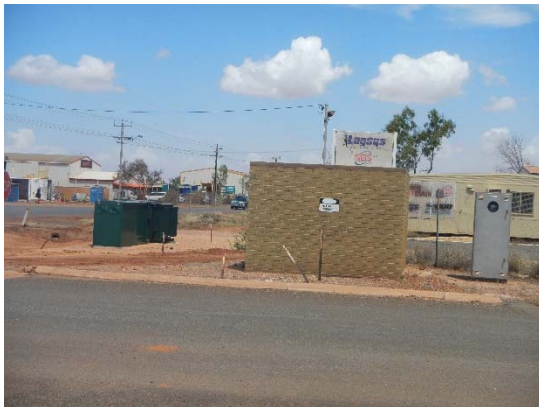
Power Substation

An investigation of the existing electrical supply capabilities and systems within buildings and facilities was completed as part of the 2010 GHD study. This has further been reviewed by the City's electrical contractor Karratha Contracting Pty Ltd and has identified in general power supply capacity and secondary switch boards within the Depot are satisfactory to meet with current and any future moderate expansions within the Depot. A detailed report is included in appendix 5.4. Further details will be elaborated in the Building Issues section of this report.

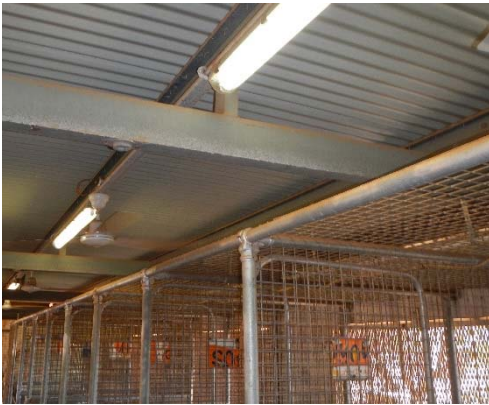
Pound Roof and Fans

4. The pound is not air-conditioned and on the day of inspection outside temperatures were in excess of 40 degrees C. The temperature inside the building was slightly cooler but fans operating in the ceiling were simply moving hot air as there is no venting system in the roof area. Currently there is adequate ventilation from the east and west sides of the building through segmental wall screening. It is recommended that cyclone compliant roof ventilation units be installed on the roof to allow the air trapped on the ceiling to be released from the building. Ranger staff advised there is no legislative requirement or need to have this building air-conditioned, however it would appear to be desirable to reduce ambient temperatures, for the comfort of staff and the animals.

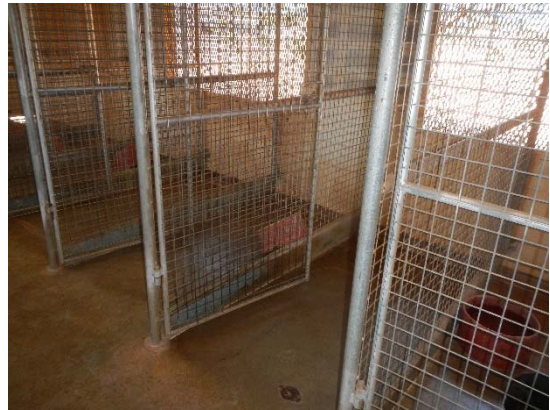
Pound Cage

1. Investigate options to improve the water pressure and internal water systems which will aid in cleaning of the cages.
2. To clean out the cages, staff are currently required to enter the cages, at times with hostile dogs. It is recommended that bricks be removed from floor height at the rear of the cages, and installation of v-channel drain on the outside of the building which will feed into the septic system. This will allow staff to remain outside of the cages while cleaning, with all waste being disposed of through the rear of the cage.

3. To ease the process of washing out the cages, it is recommended that a central feed line be installed above head height in the main corridor which will enable a gurney and spray gun to be easily connected, allowing free access to all cages along the feed line.

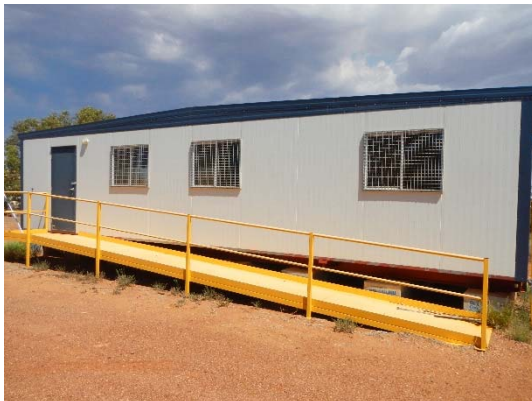
Cattery

This facility was constructed in 2013. The facility is functional and currently meets operational needs. Internal storage shelving would improve access to stored materials.

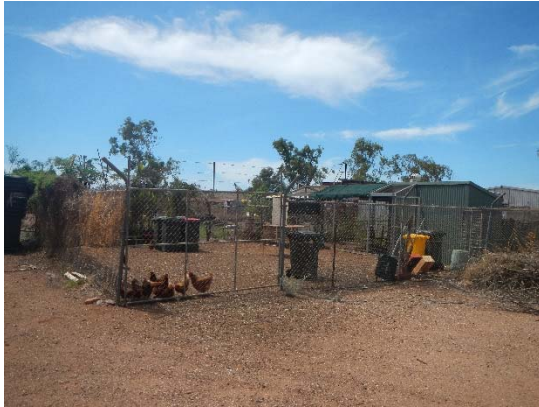
Chicken coop

The Health Department yard has a fowl hen house where hens are kept for taking blood samples. This facility is adequate for the purpose with light vehicle access to the area being retained.

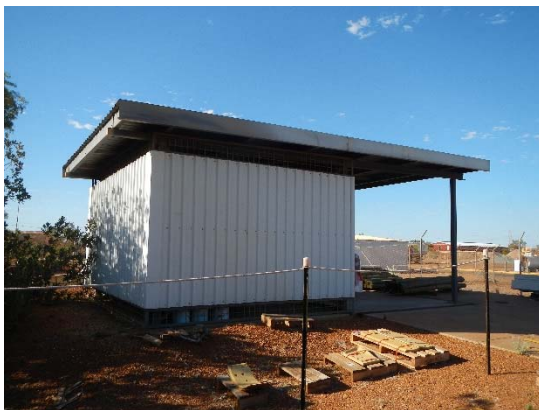
Exterior Dangerous Goods Store

This store meets current requirements, with unleaded fuel in 200L drums being the only item currently stored within the partly open secured shed.

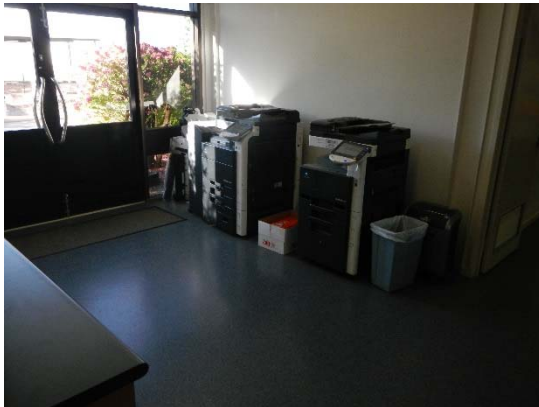
Existing Printing Area

5. A purpose built print room is recommended to house the plotter, printers and store paper. If a new reception area was created in another new building the existing reception area could possibly be transformed for this purpose.

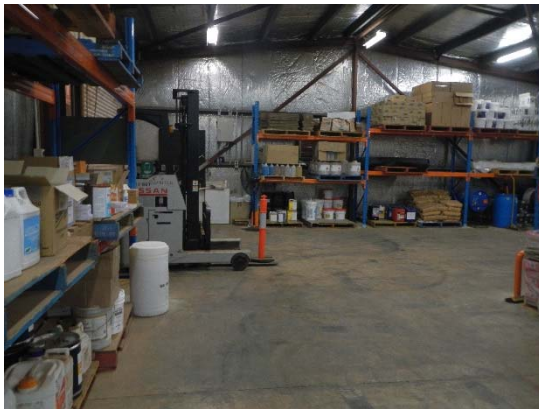
Chemicals in the Store

A detailed evaluation of all listed dangerous within the Depot is recommended by the Depot Operations team to prepare a strategy for the effective safe and secure storage of the required goods.

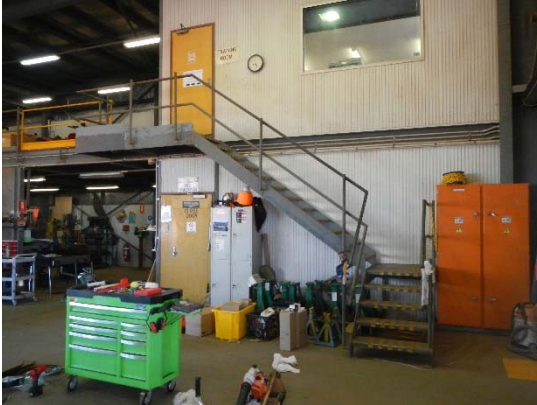
Stairs to Mezzanine

1. The access stairs leading to the mezzanine area are not compliant and are required to be replaced.
2. Emergency lighting and illuminated door exit signs area required to be installed in this building.
3. Personal exit doors have dead bolts that must be removed and a similar system could be implemented to the store area for added cyclone door security. These doors also require the latch system to be replaced with a compliant door handle.
