EXTENSION OF APPROVAL PERIOD - LOT 500 MADIGAN ROAD DEVELOPMENT PLAN
WAPC REFERENCE: SPN/0244M-1

**REVISED STRUCTURE PLAN AMENDMENT – MADIGAN ROAD, KARRATHA
IMPACT OF PROPOSED SCHOOL SITE IN STAGE 3 ON THE LOCAL WATER MANAGEMENT STRATEGY**

JDA previously prepared a Local Water Management Strategy (LWMS) to support the Madigan Road Structure Plan. A revised structure plan amendment is now proposed to include a School in Stage 3 (see Plan 1 attached).

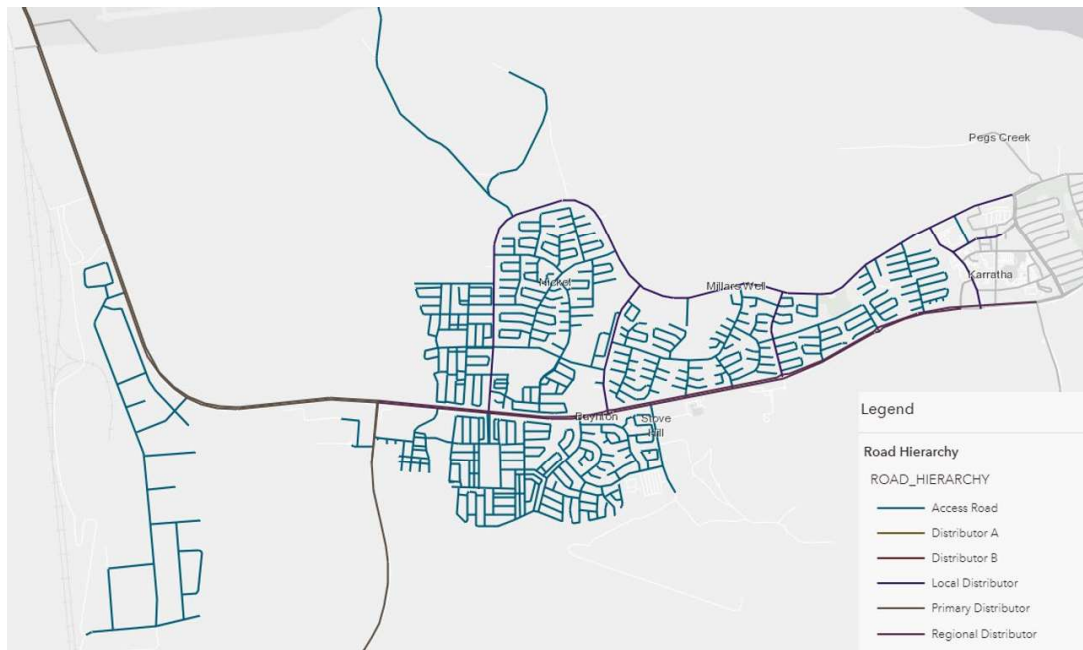
Figure 2: Existing road network and road hierarchy

The existing road network and its classification in the Main Roads WA functional road hierarchy is illustrated in **Figure 2**.

Dampier Road north of the subject site, is a dual carriageway, four lanes divided road with solid median in the vicinity of subject site. It is classified as a *Regional Distributor* road in the Main Roads WA *Functional Road Hierarchy* to the east of Madigan Road and operates under the speed limit of 70km/h (refer **Figure 3**).

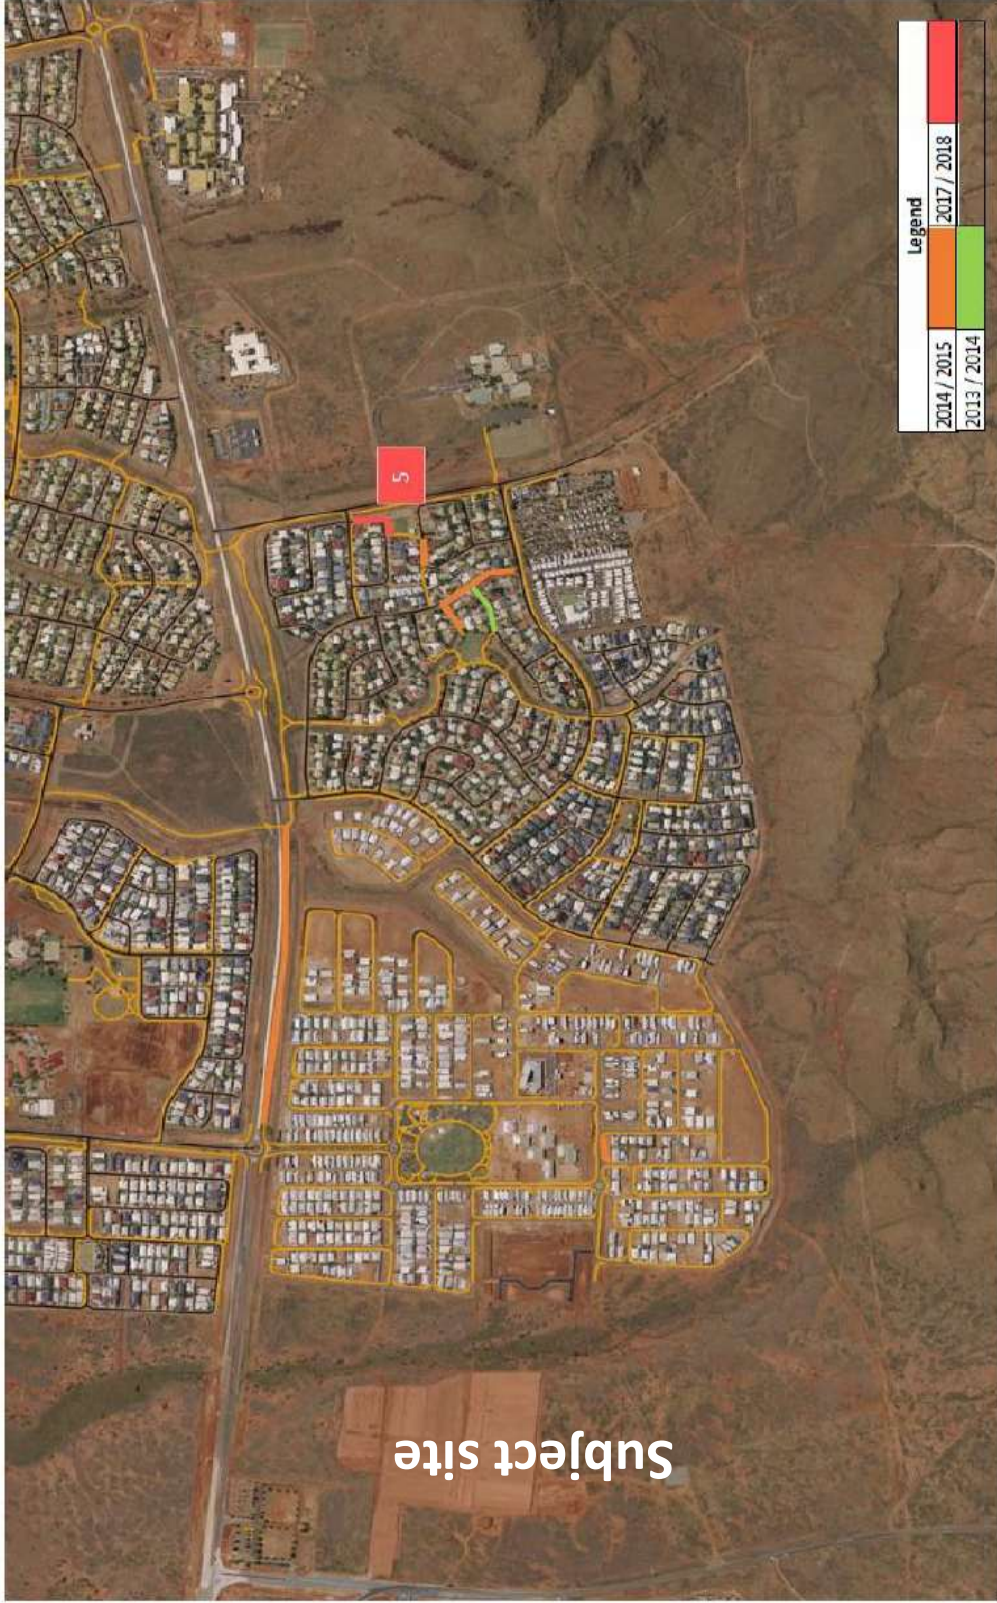
Figure 6: Bike map

The Future Works Report Footpaths 2013-2023 provides a guide for ongoing development of footpath networks in the Shire of Roebourne projected over the next ten years. **Figure 6** shows the existing paths along Dampier Road and internal road network within Baynton West locality which has been developed since 2013. It is expected that the proposed pedestrian and cycle paths of the amended SP would also connect to the surrounding paths once fully developed.

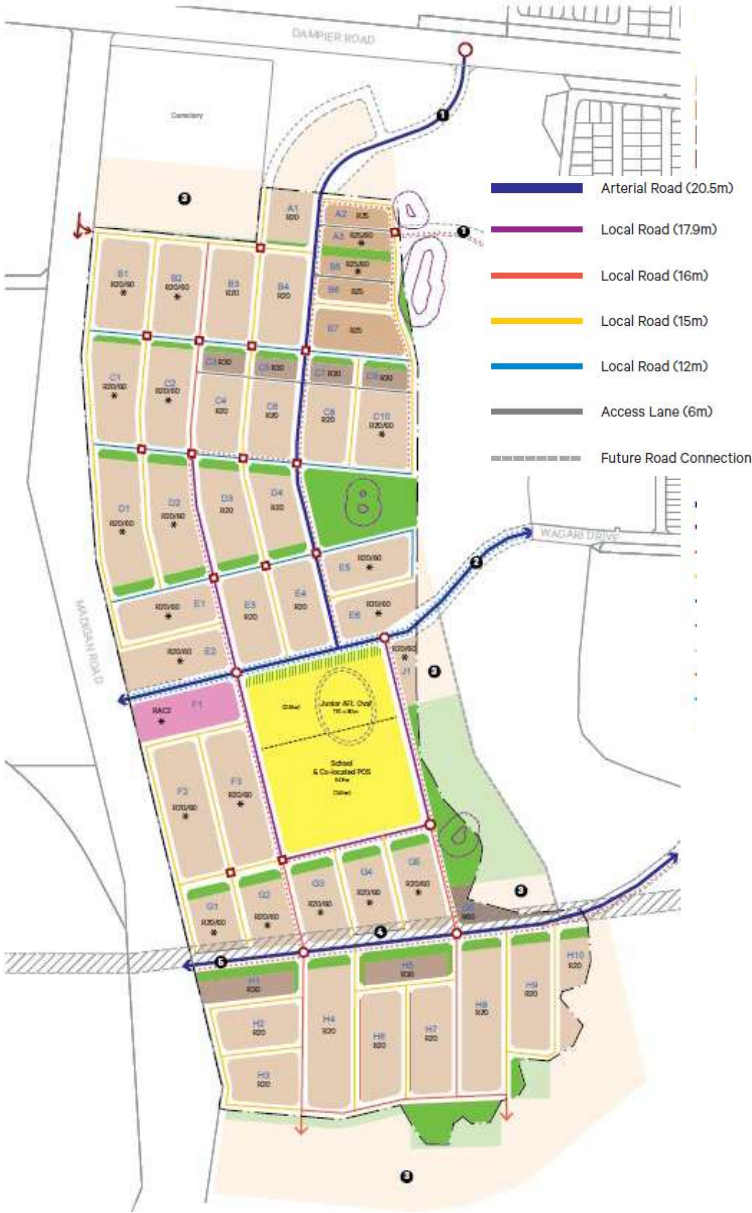
Figure 8: Proposed road hierarchy

The proposed hierarchy of roads within the amended SP was established through transport modelling undertaken for the site and are illustrated in **Figure 8** which is line with the hierarchy and classification of the approved SP.

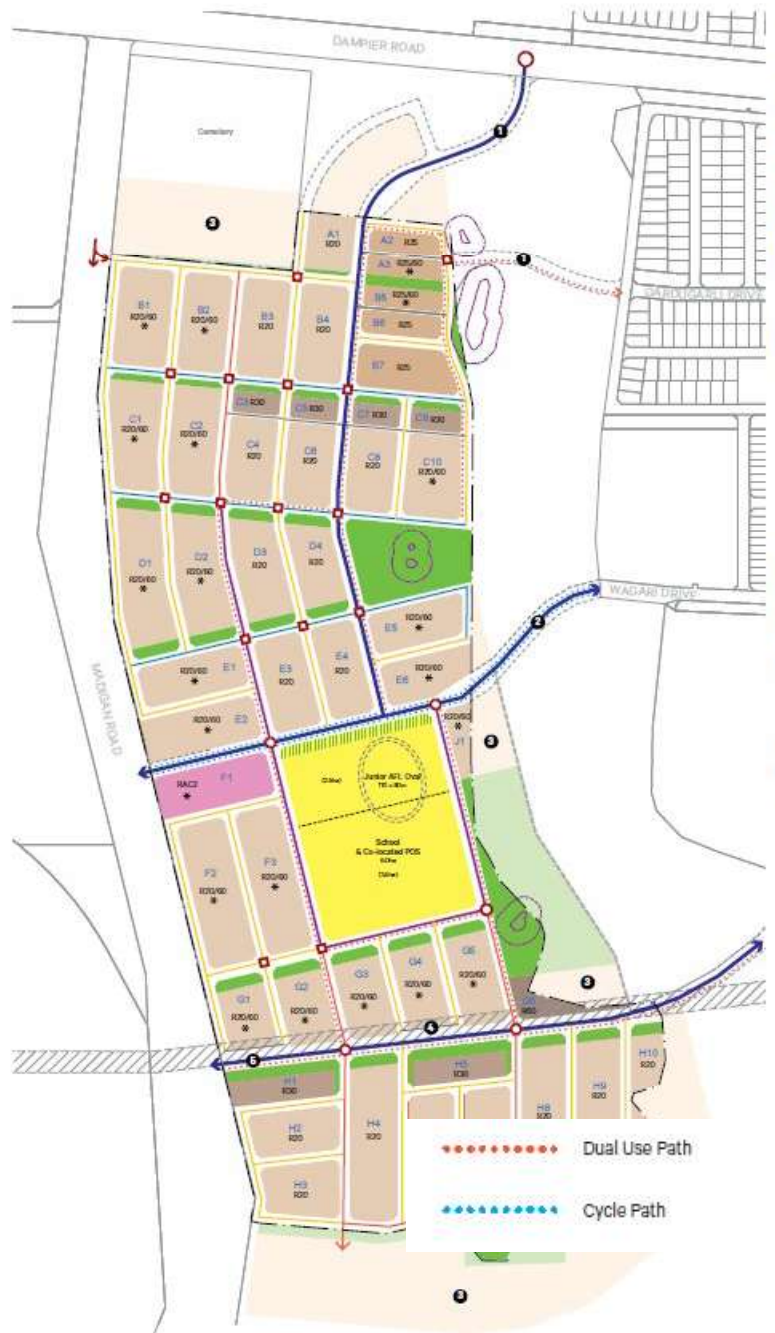
Figure 9: Proposed pedestrian and cyclist road network

Figure 9 outlines the proposed pedestrian and cyclist network for the proposed amended SP. In accordance with the LN guidelines, shared paths are proposed on one side of the neighbourhood connector roads with a footpath on the other side. The shared paths (dual use paths) are also provided along the access street B which forms the boundary of the proposed school site.

The proposed shared paths (dual use paths) within the amended SP area provide strong north-south and east-west linkages between neighbourhood focal points and key attractions such as the local centre, local and regional open space areas as well as linkages with the Baynton West residential area and the proposed school site.

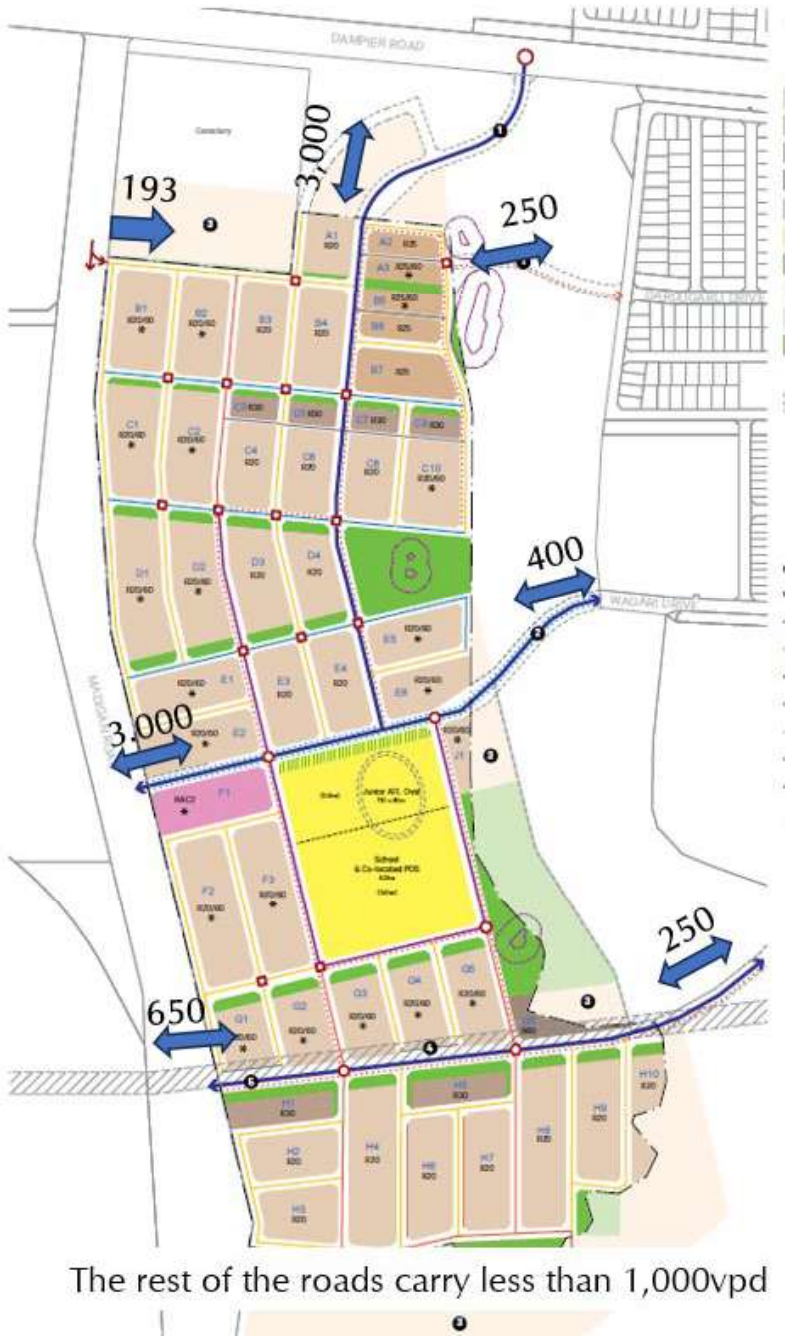
Figure 10: Projected daily traffic volumes

Figure 9 shows the projected (2035) daily traffic volumes on the amended SP internal roads.

The rest of the roads carry less than 1,000vpd

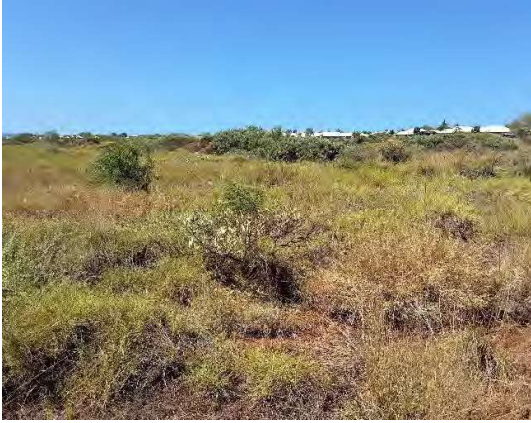
Plot 1	Classification or exclusion clause:	Class C Shrubland
	Effective slope:	All upslopes and flat land (0 degrees)
Photo Point 1 Classified vegetation within this plot is predominantly less than 2 m in height with a foliage cover greater than 30%. The understorey is characterised by dense low shrubs and grasses. This site is associated with Madigan Creek. Vegetation is situated on flat land.

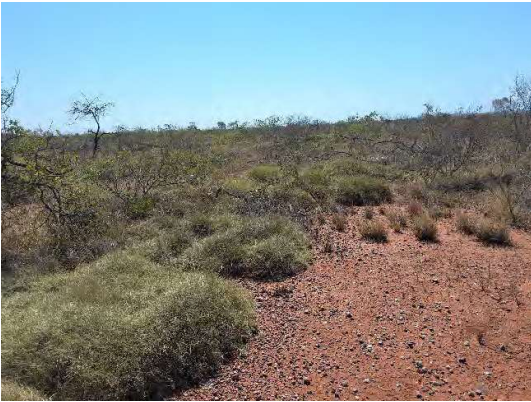
Plot 1	Classification or exclusion clause:	Class C Shrubland
	Effective slope:	All upslopes and flat land (0 degrees)
Photo Point 2 Classified vegetation within this plot is predominantly less than 2 m in height with a foliage cover greater than 30%. The understorey is characterised by dense low shrubs and grasses. Vegetation is situated on flat land.

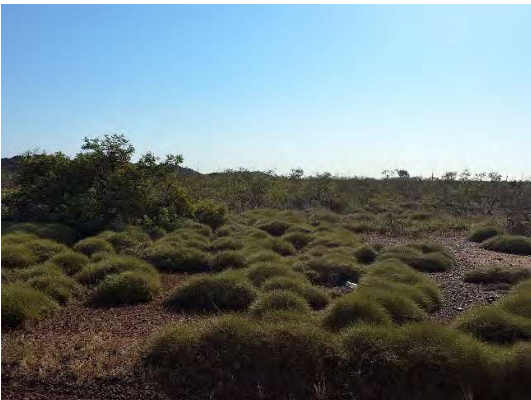
Plot 1	Classification or exclusion clause:	Class C Shrubland
	Effective slope:	All upslopes and flat land (0 degrees)
Photo Point 3 (background) Classified vegetation within this plot is predominantly less than 2 m in height with a foliage cover greater than 30%. The understorey is characterised by dense low shrubs and grasses. Vegetation is situated on flat land.

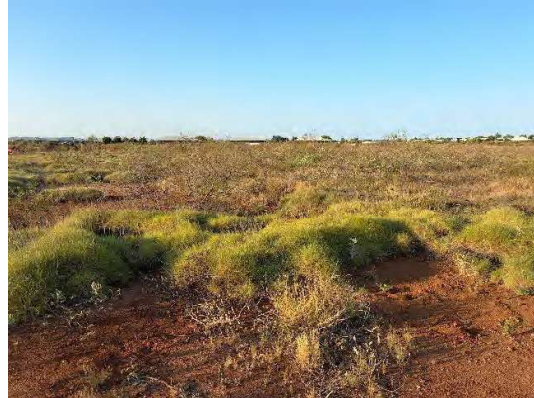
Photo Point 4

Plot 1	Classification or exclusion clause:	Class C Shrubland
	Effective slope:	All upslopes and flat land (0 degrees)

Classified vegetation within this plot is predominantly less than 2 m in height with a foliage cover greater than 30%. The understorey is characterised by dense low shrubs and grasses.

Vegetation is situated on flat land.

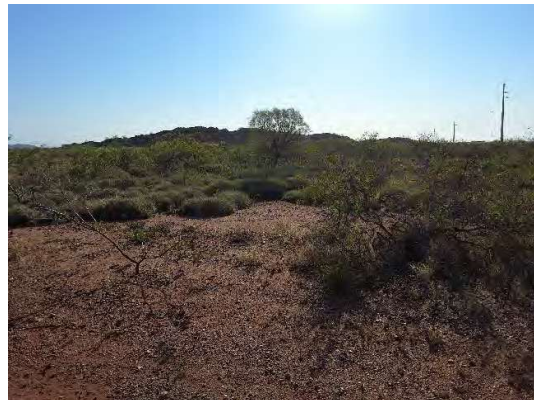
Photo Point 5

Plot 1	Classification or exclusion clause:	Class C Shrubland
	Effective slope:	All upslopes and flat land (0 degrees)

Classified vegetation within this plot is predominantly less than 2 m in height with a foliage cover greater than 30%. The understorey is characterised by dense low shrubs and grasses.

Vegetation is situated on flat land.

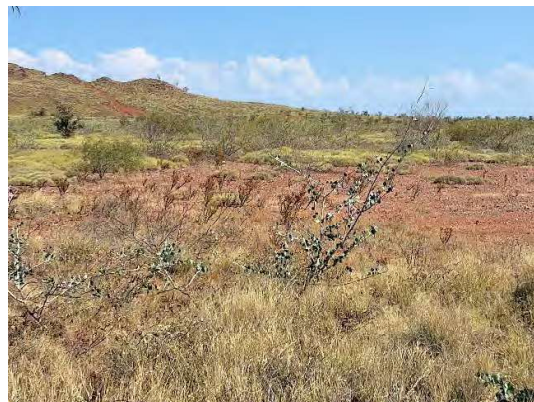
Photo Point 6

Plot 1	Classification or exclusion clause:	Class C Shrubland
	Effective slope:	All upslopes and flat land (0 degrees)

Classified vegetation within this plot is predominantly less than 2 m in height with a foliage cover greater than 30%. The understorey is characterised by dense low shrubs and grasses.

Vegetation is situated on flat land.

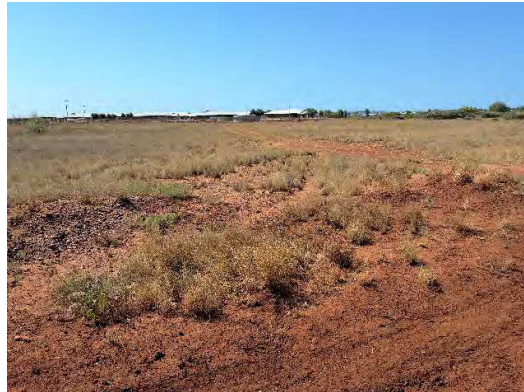
Photo Point 7

Plot 2	Classification or exclusion clause:	Class G Grassland
	Effective slope:	All upslopes and flat land (0 degrees)

Classified vegetation within this plot is predominantly grassland with foliage cover from the overstorey less than 10%.

Vegetation is situated on flat land.

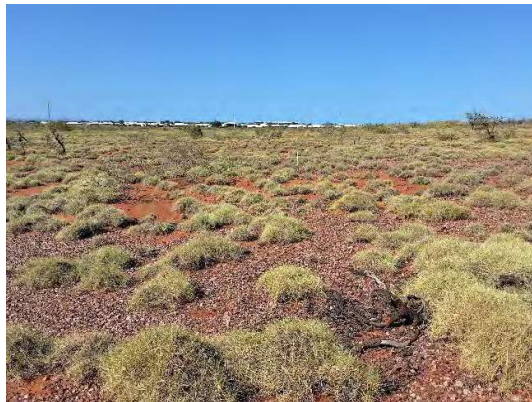
Photo Point 8

Plot 2	Classification or exclusion clause:	Class G Grassland
	Effective slope:	All upslopes and flat land (0 degrees)

Classified vegetation within this plot is predominantly grassland with foliage cover from the overstorey less than 10%.

Vegetation is situated on flat land.

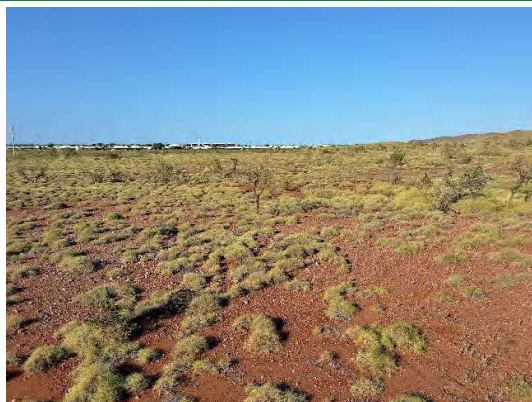
Photo Point 9

Plot 2	Classification or exclusion clause:	Class G Grassland
	Effective slope:	All upslopes and flat land (0 degrees)

Classified vegetation within this plot is predominantly grassland with foliage cover from the overstorey less than 10%.

Vegetation is situated on flat land.

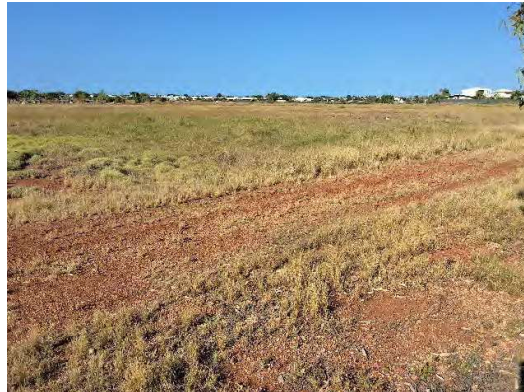
Photo Point 10

Plot 2	Classification or exclusion clause:	Class G Grassland
	Effective slope:	All upslopes and flat land (0 degrees)

Classified vegetation within this plot is predominantly grassland with foliage cover from the overstorey less than 10%.

Vegetation is situated on flat land.

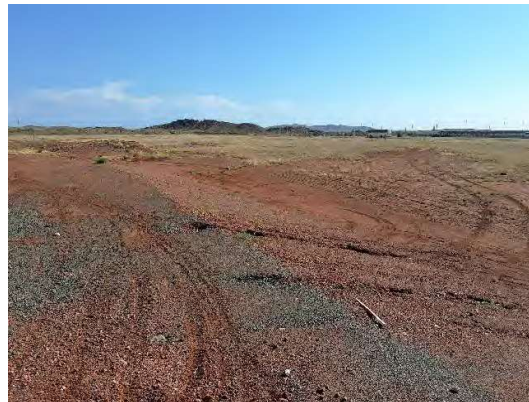
Photo Point 11 (background)

Plot 2	Classification or exclusion clause:	Class G Grassland
	Effective slope:	All upslopes and flat land (0 degrees)

The foreground comprises the APZ currently over Stage 2D.

Vegetation is situated on flat land.

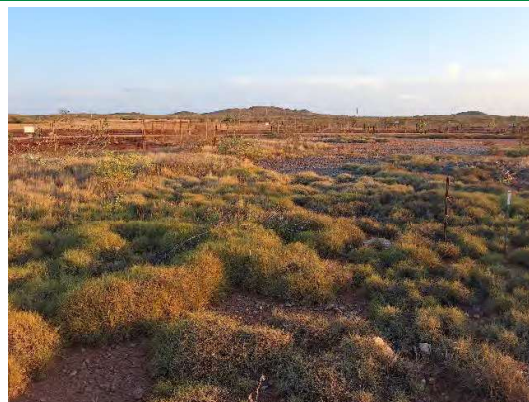
Photo Point 12 (foreground)

Plot 3	Classification or exclusion clause:	Excluded AS 3959-2018 2.2.3.2 (c)
	Effective slope:	-

This plot relates to the heritage site within the POS of Stage 2C. While it involves the retention of Class G Grassland, this plot has been excluded under Clause 2.2.3.2 (c) as the POS has already been developed and is >20 m from classified vegetation to the east and >20 m from residential lots.

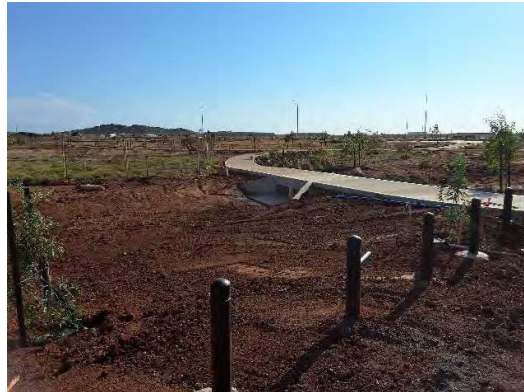
Photo Point 13

Plot 4	Classification or exclusion clause:	Excluded AS 3959-2018 2.2.3.2 (e) and (f)
	Effective slope:	-

This plot comprises the POS associated with Stage 2C. With the exception of the Class G Grassland plot that has been retained (left midground of photo, and illustrated in Photo Point 11), the remainder of the POS has been cleared and managed to a low threat state and as such, has been excluded under clause 2.2.3.2 (e) & (f) AS 3959:2018.

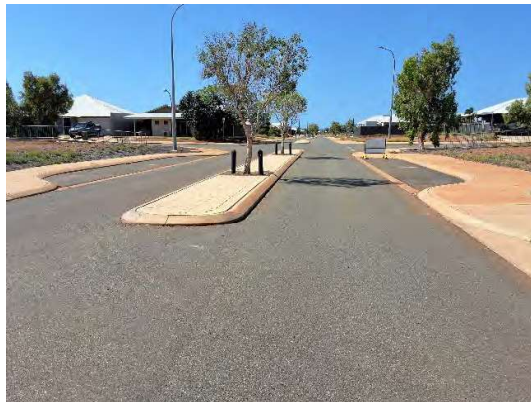
Photo Point 14

Plot 4	Classification or exclusion clause:	Excluded AS 3959-2018 2.2.3.2 (e) and (f)
	Effective slope:	-

This photograph depicts Prancing Ave in the northern portion of the subject site comprising roads, footpaths, vegetation managed to a low threat state and residential buildings with landscaped gardens.

This plot has been excluded under clause 2.2.3.2 (e) & (f) of AS 3959:2018.

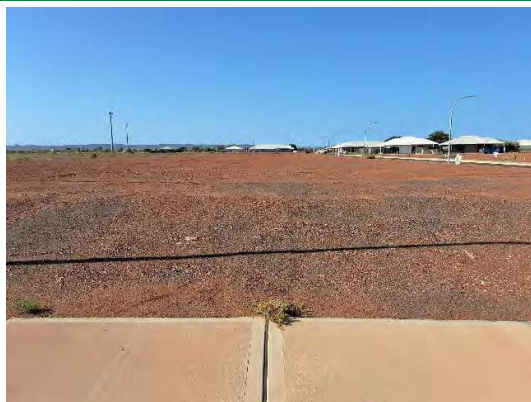
Photo Point 15

Plot 4	Classification or exclusion clause:	Excluded AS 3959-2018 2.2.3.2 (e) & (f)
	Effective slope:	-

This plot has been excluded under clause 2.2.3.2 (e) & (f) of AS 3959:2018. This area currently comprises roads, a footpath and land cleared for development. Future development will involve residential buildings with landscaped gardens.

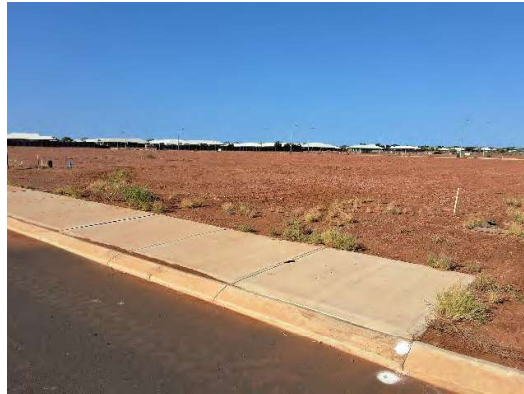
Photo Point 16

Plot 4	Classification or exclusion clause:	Excluded AS 3959-2018 2.2.3.2 (e) and (f)
	Effective slope:	-

This plot has been excluded under clause 2.2.3.2 (e) & (f) of AS 3959:2018. This area currently comprises roads, a footpath and land cleared for development. Future development will involve residential buildings with landscaped gardens.

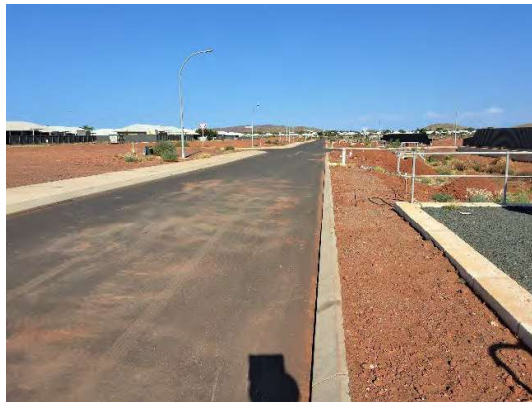
Photo Point 17

Plot 4	Classification or exclusion clause:	Excluded AS 3959-2018 2.2.3.2 (e) and (f)
	Effective slope:	-

This plot has been excluded under clause 2.2.3.2 (e) & (f) of AS 3959:2018. This area currently comprises roads, a footpath and land cleared for development. Future development will involve residential buildings with landscaped gardens.

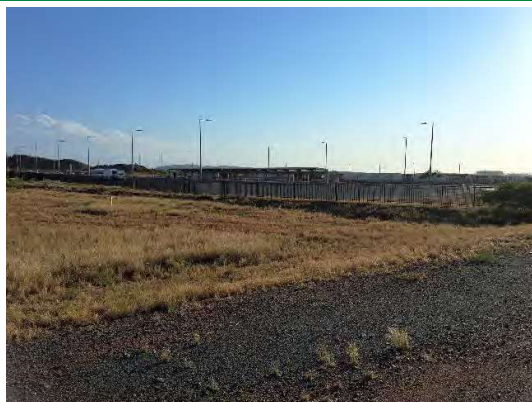
Photo Point 18 (background)

Plot 4	Classification or exclusion clause:	Excluded AS 3959-2018 2.2.3.2 (e) & (f)
	Effective slope:	-

This plot has been excluded under clause 2.2.3.2 (e) & (f) of AS 3959:2018. This area comprises a bus depot to the west of Madigan Road.

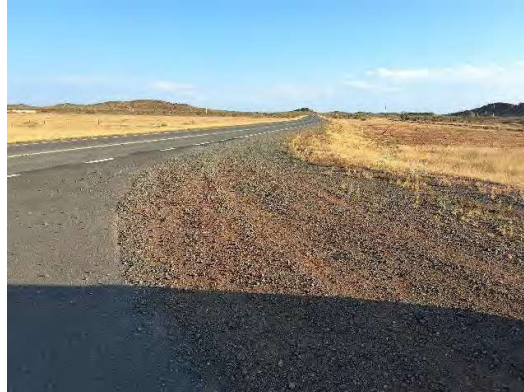
Photo Point 19

Plot 4	Classification or exclusion clause:	Excluded AS 3959-2018 2.2.3.2 (e) and (f)
	Effective slope:	-

This photo point depicts Madigan Road to the west of the subject site. Madigan Road has been excluded under clause 2.2.3.2 (e) & (f) of AS 3959:2018.

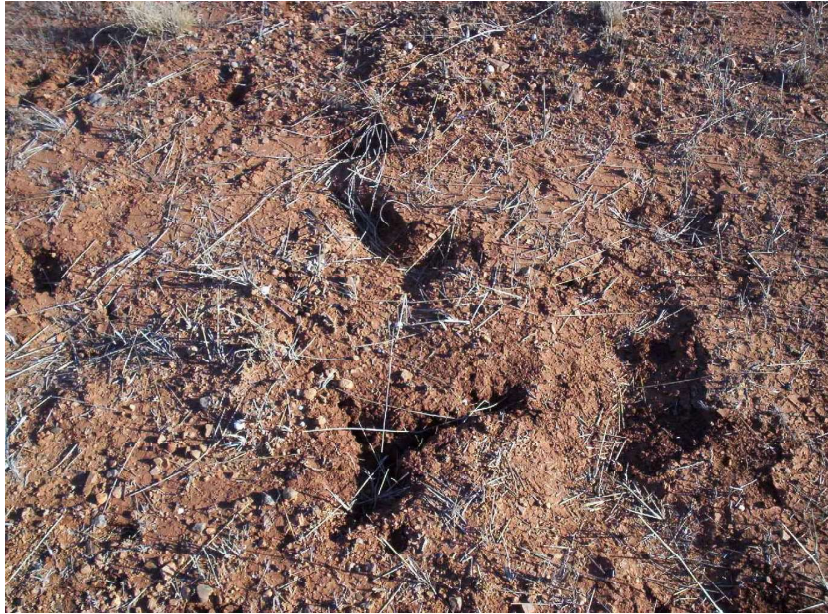
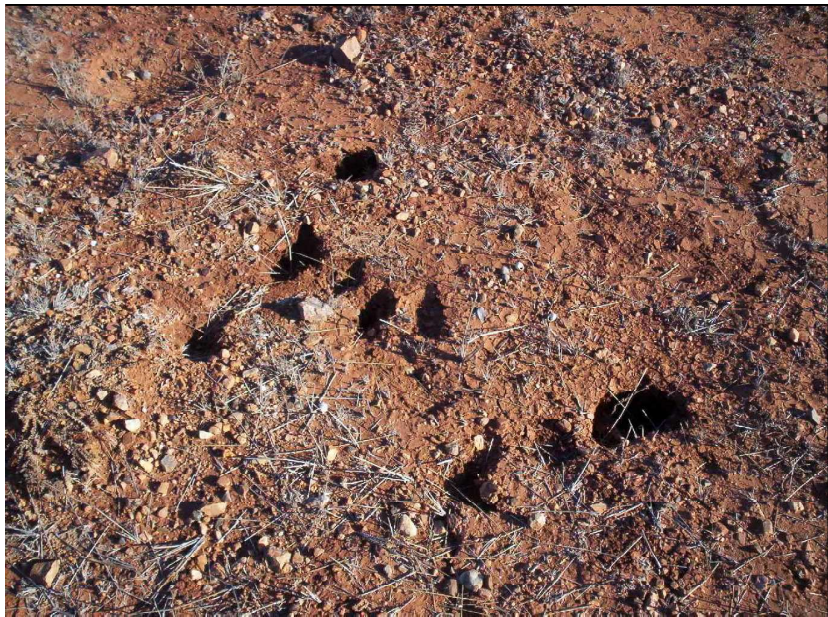
EXAMPLE OF GILGAI SOILS

A common feature within the alluvial – colluvial plain throughout the site is the occurrence of “crabholes” indicating Gilgai soils. Gilgai is extremely reactive to changes in soil moisture and shrinks and swells to depths of 1m to 2m in response to seasonal wetting and drying. The resulting terrain, noted throughout the site, consists of small hummocks and hollows with “crabholes” (Figure 2) in the hollows being more concentrated in shallow water courses and lower lying areas where surface water ponds following rainfall events.

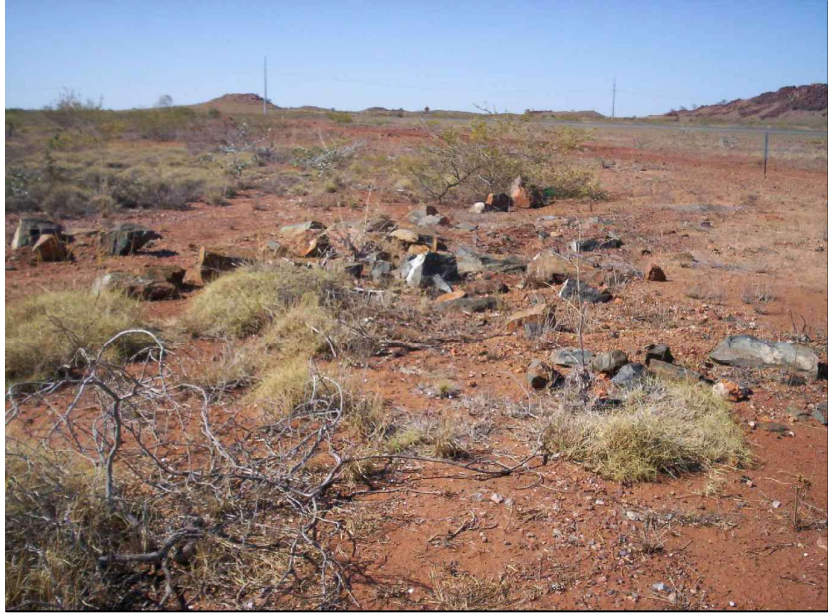
LOCALISED ROCK OUTCROPS WITHIN THE SITE

Rock outcrops were observed in the central and southern sections of the site (Figure 3), with moderately to highly fractured rock outlays present at the base of the foothills (Figure 4).

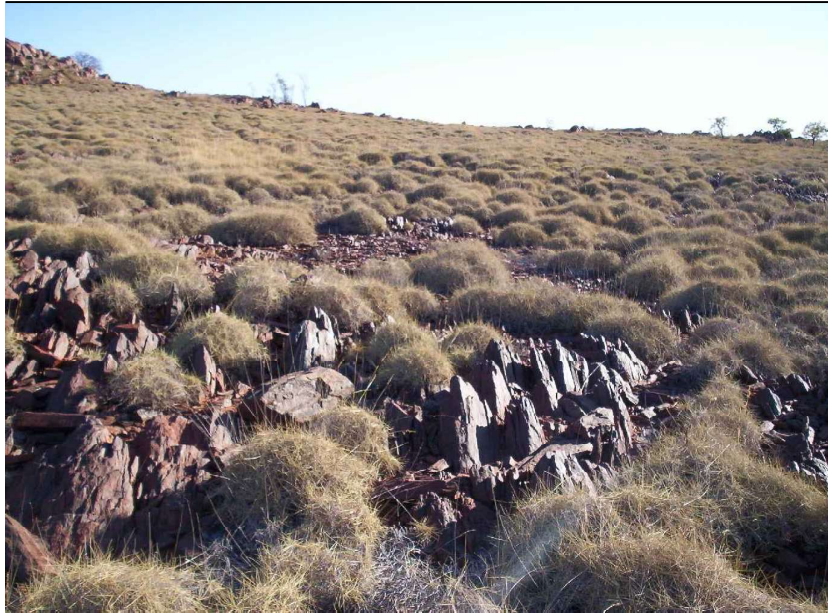
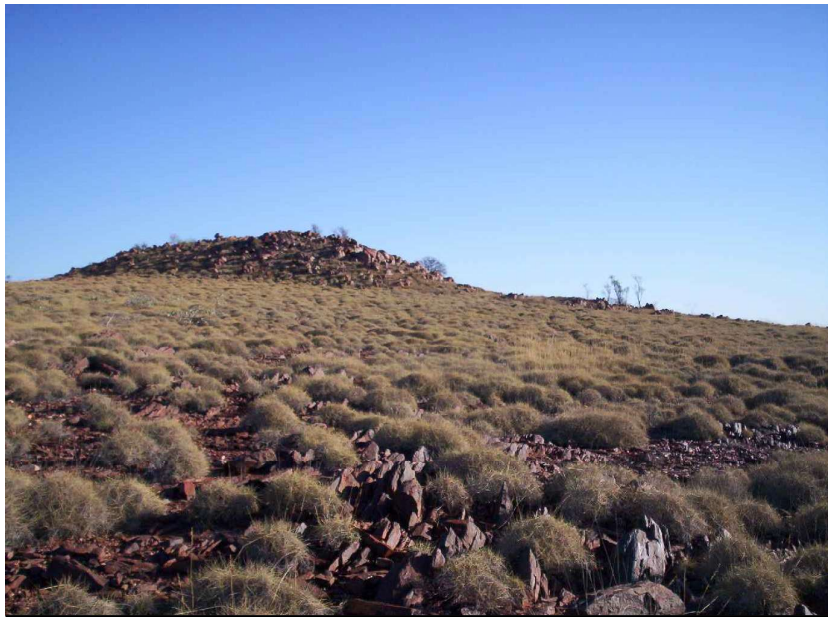
SURFICIAL ROCK AT THE BASE OF KARRATHA HILLS

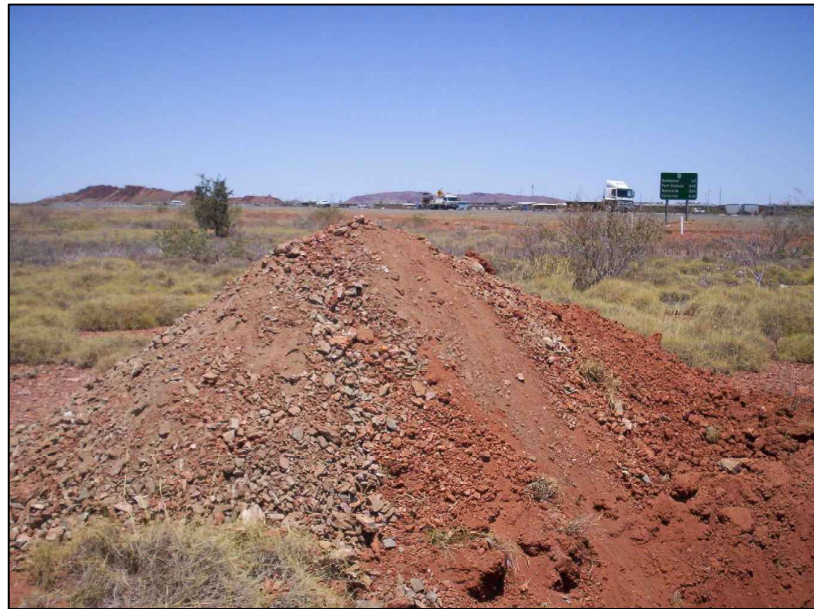
TP01 - Stockpile.

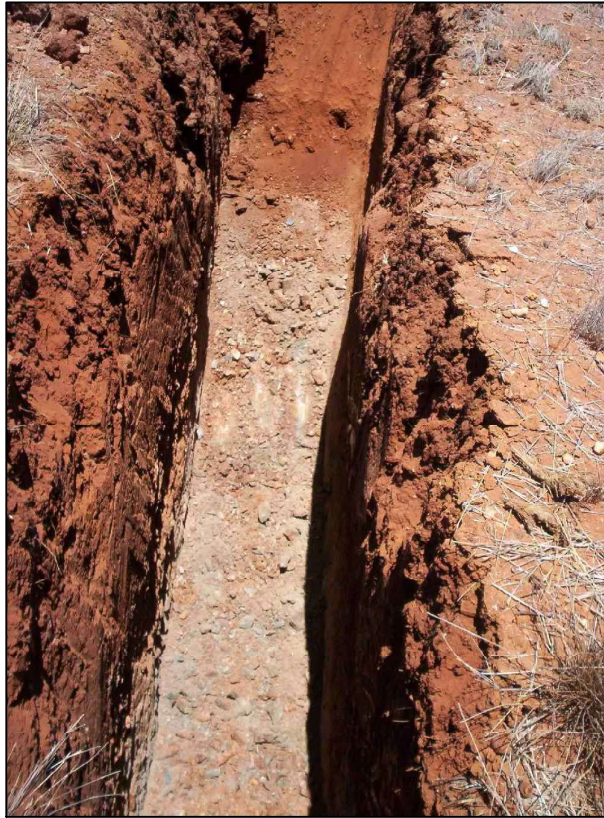
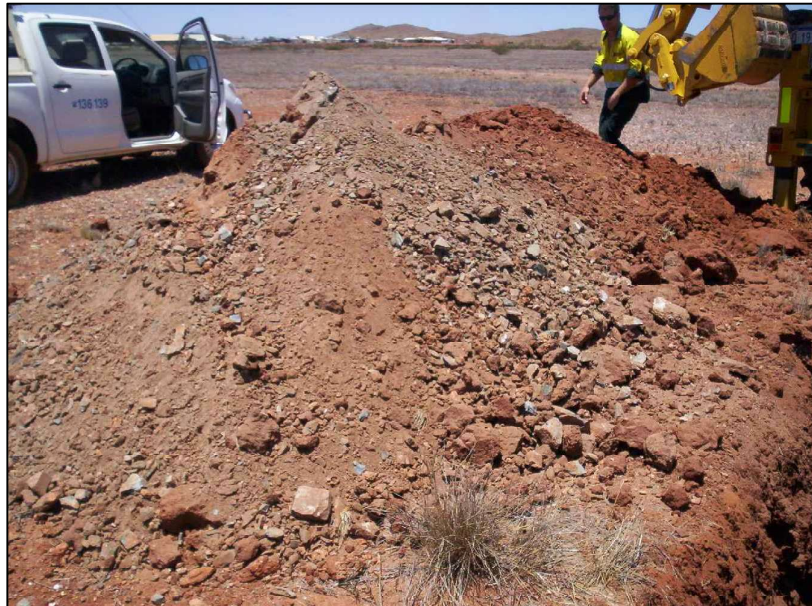
TP02.

TP02 - Stockpile.

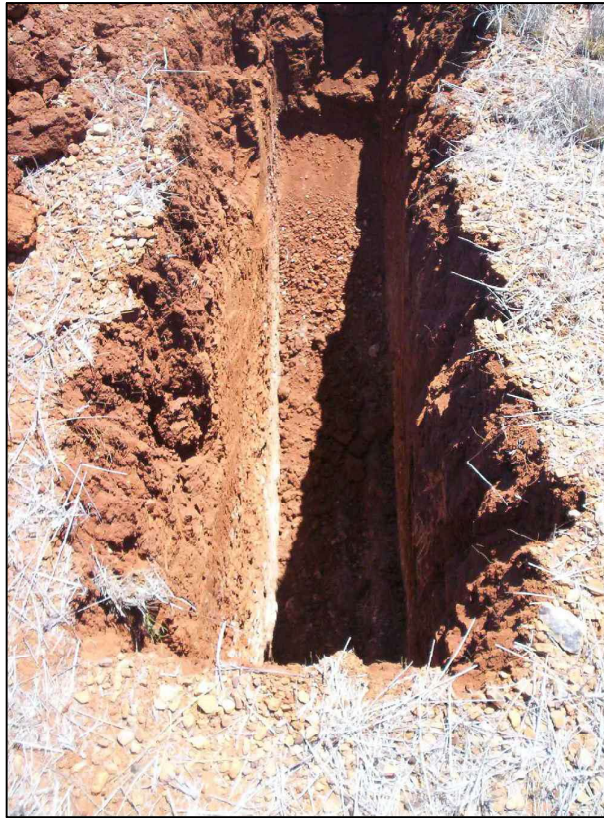
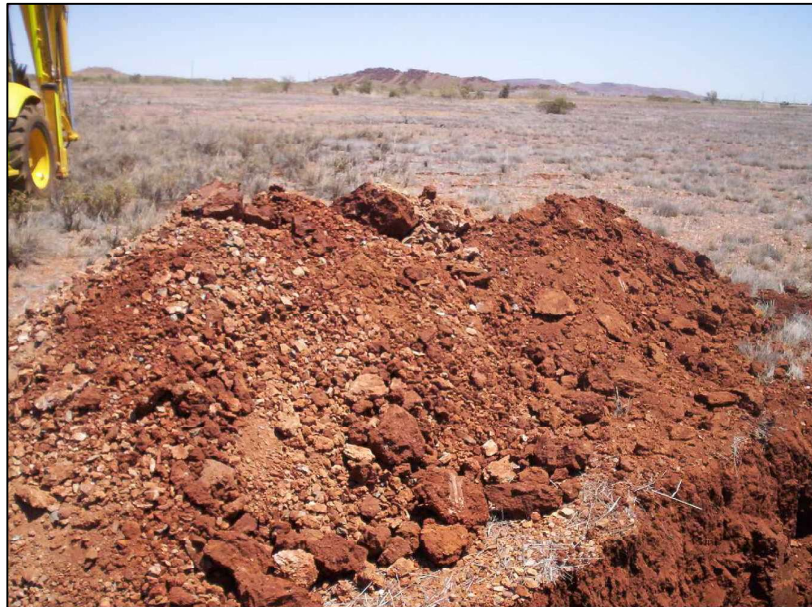
TP03.

TP03 - Stockpile.

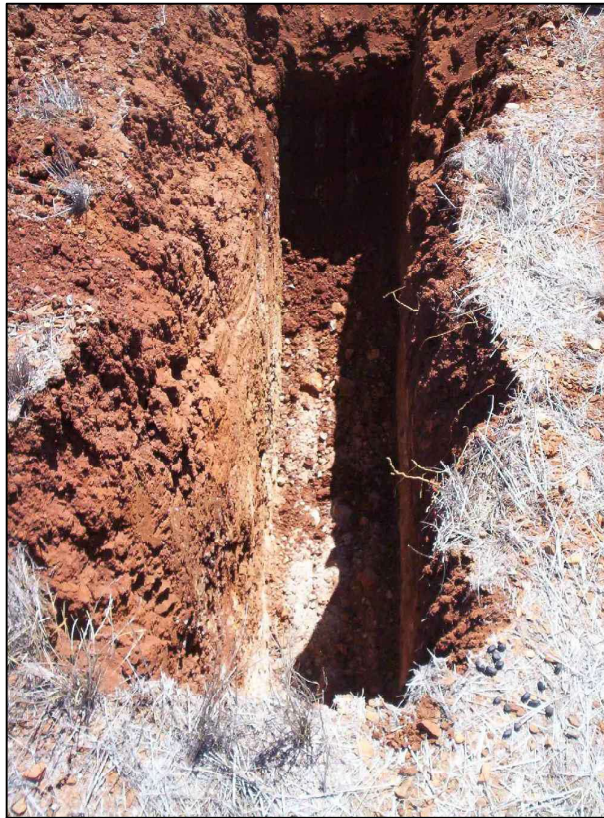
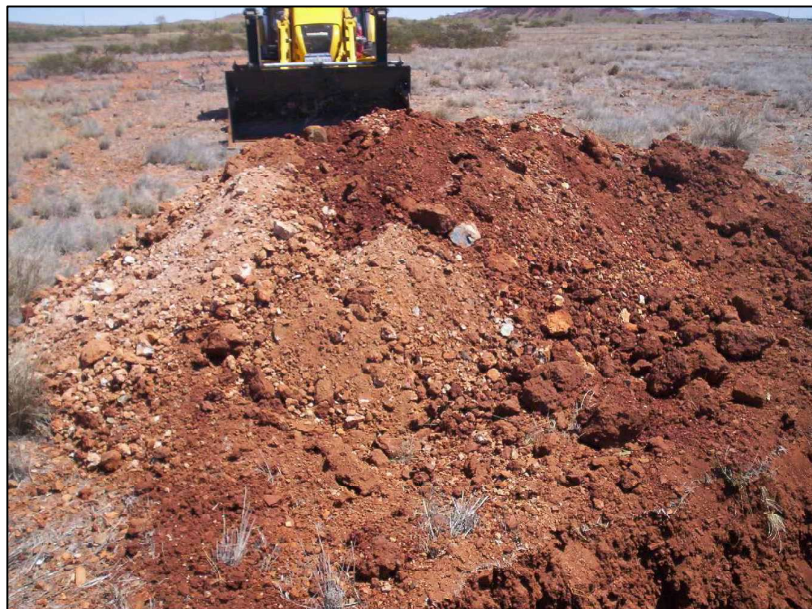
TP04.

TP04 - Stockpile.

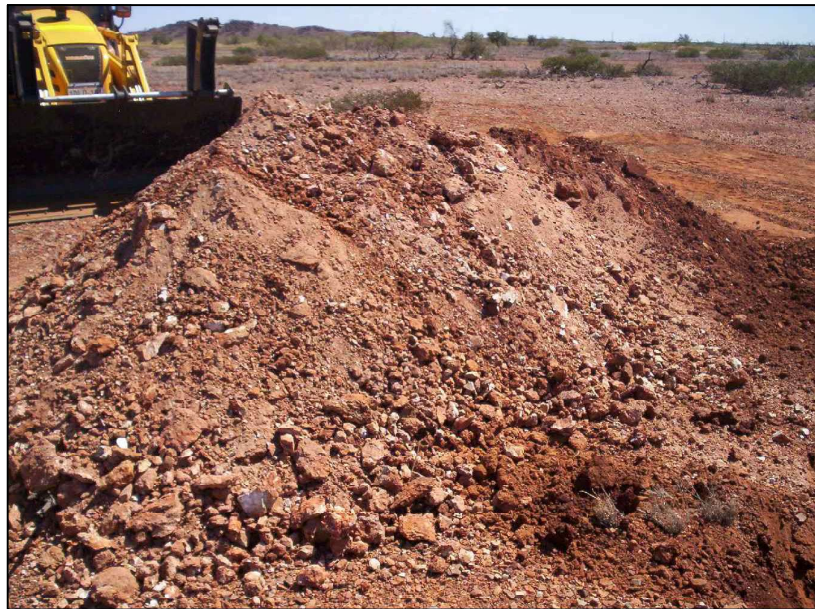
TP05 - Stockpile.

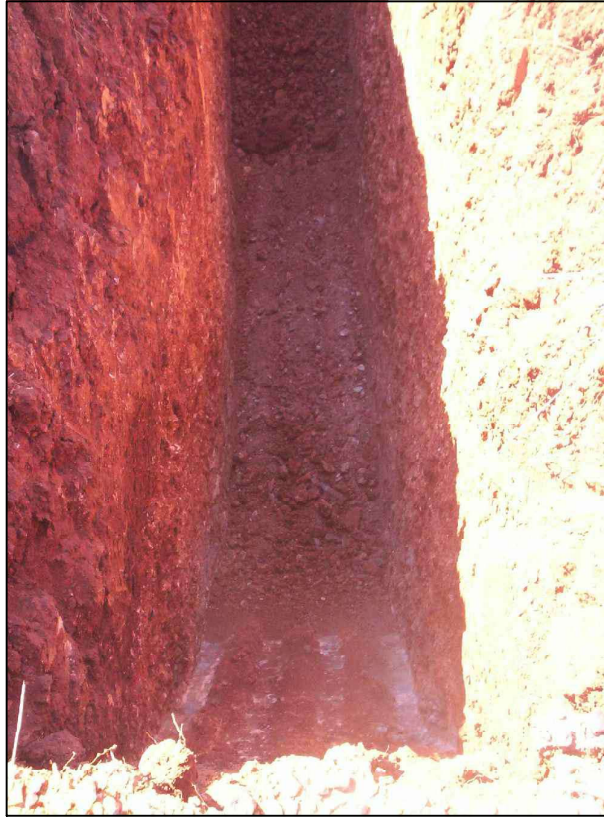
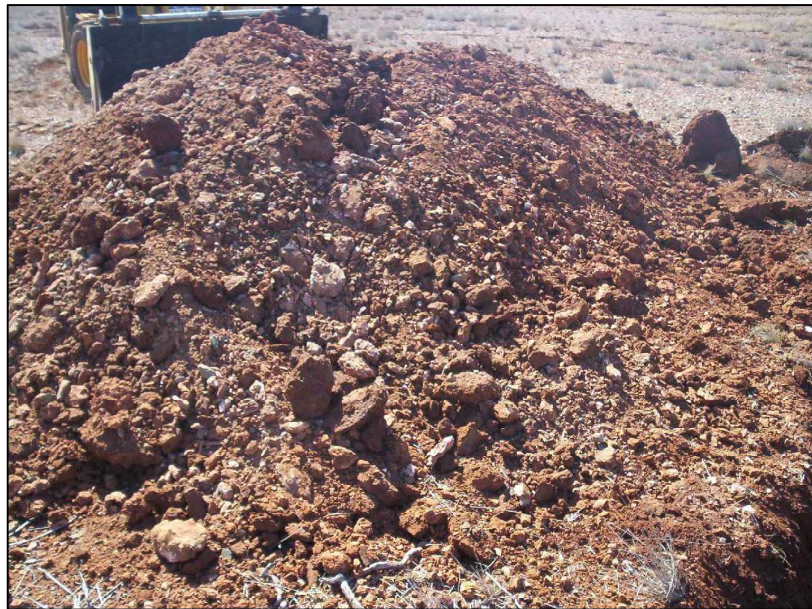
TP06.

TP06 - Stockpile.

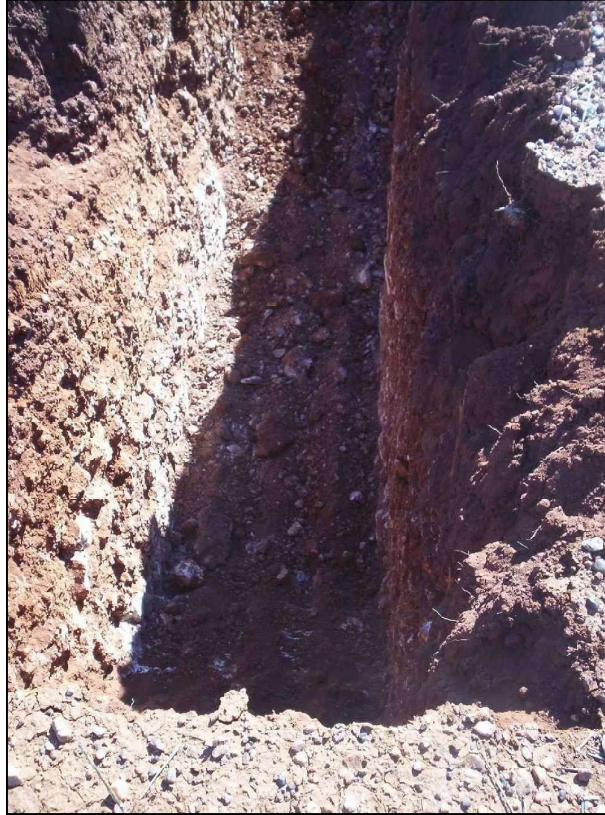
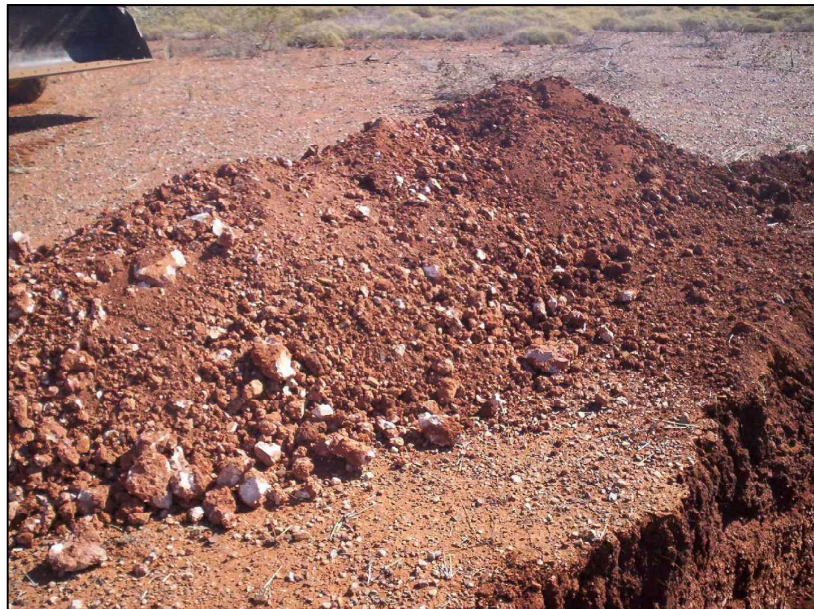
TP07.

TP07 - Stockpile.

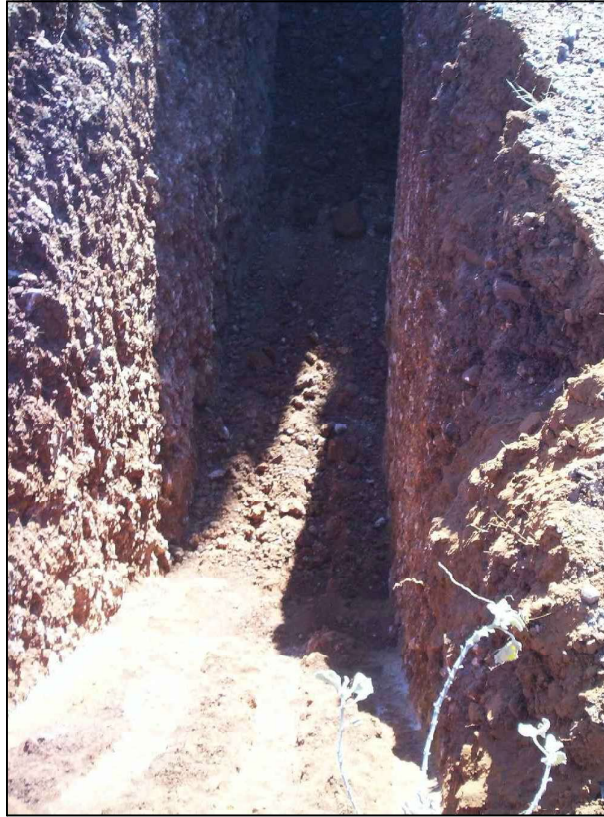
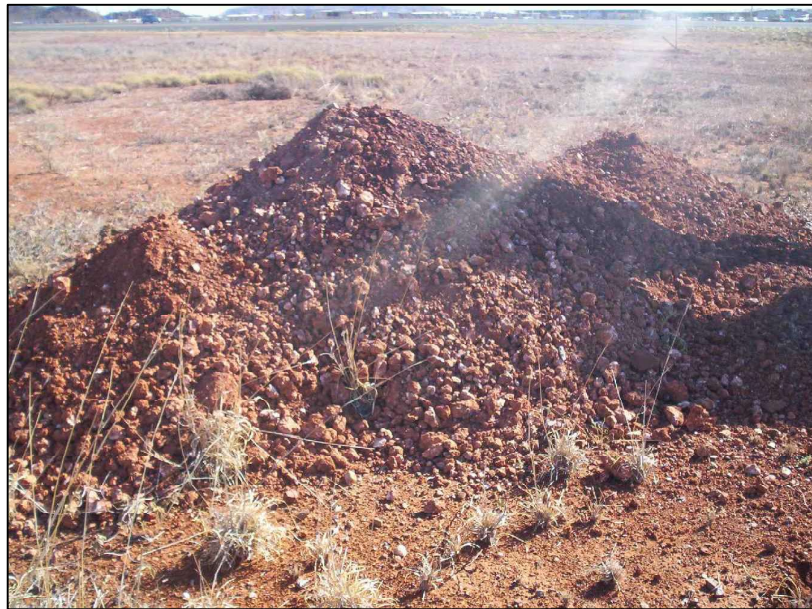
TP08.

TP08 - Stockpile.

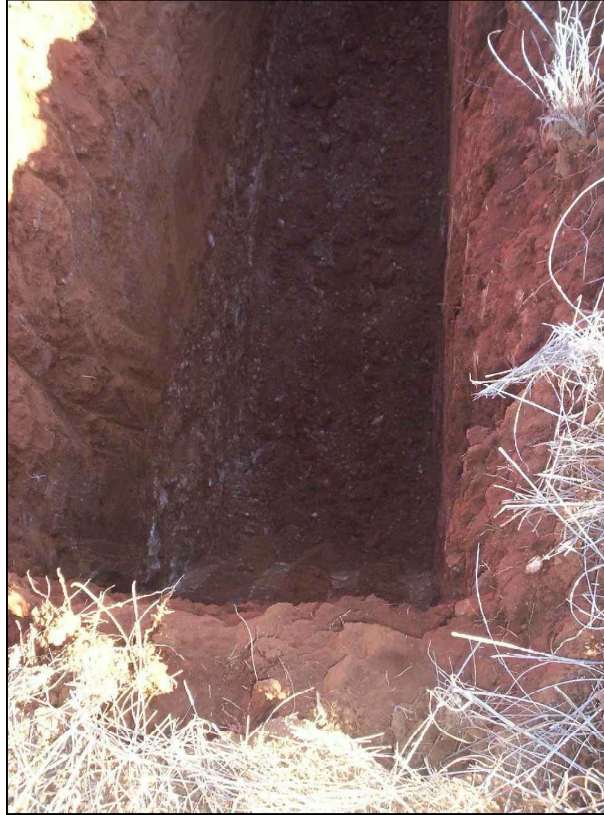
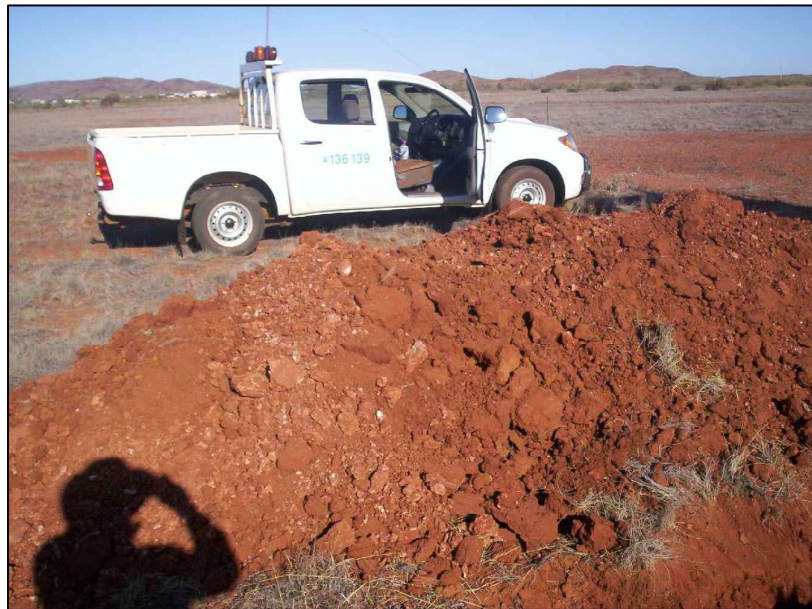
TP09.

TP09 - Stockpile.

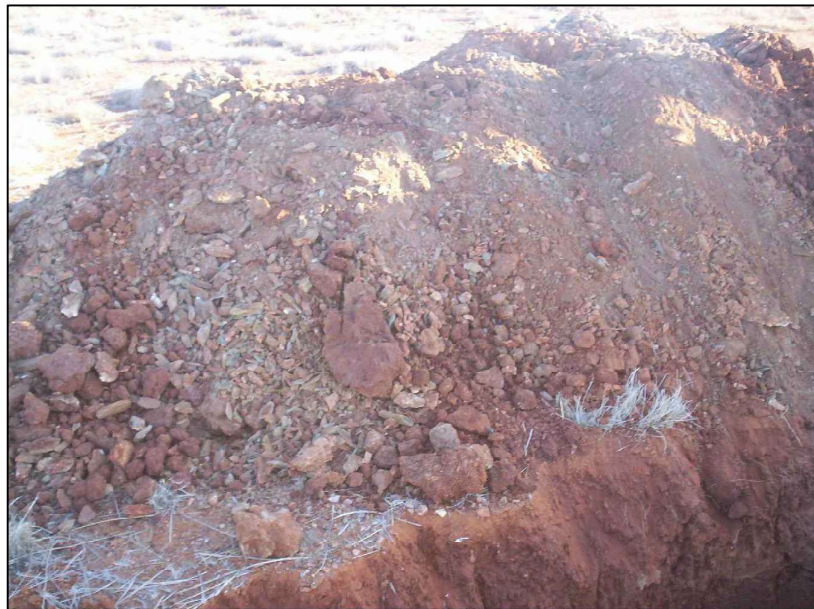
TP10 - Stockpile.
