EXTENSION OF APPROVAL PERIOD - LOT 500 MADIGAN ROAD DEVELOPMENT PLAN
WAPC REFERENCE: SPN/0244M-1

**REVISED STRUCTURE PLAN AMENDMENT – MADIGAN ROAD, KARRATHA
IMPACT OF PROPOSED SCHOOL SITE IN STAGE 3 ON THE LOCAL WATER MANAGEMENT STRATEGY**

JDA previously prepared a Local Water Management Strategy (LWMS) to support the Madigan Road Structure Plan. A revised structure plan amendment is now proposed to include a School in Stage 3 (see Plan 1 attached).

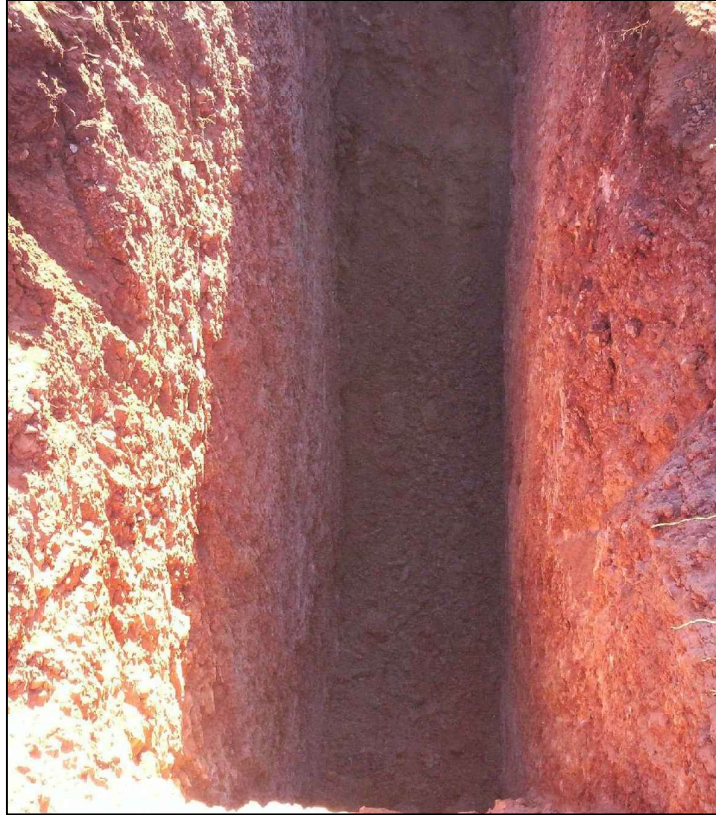
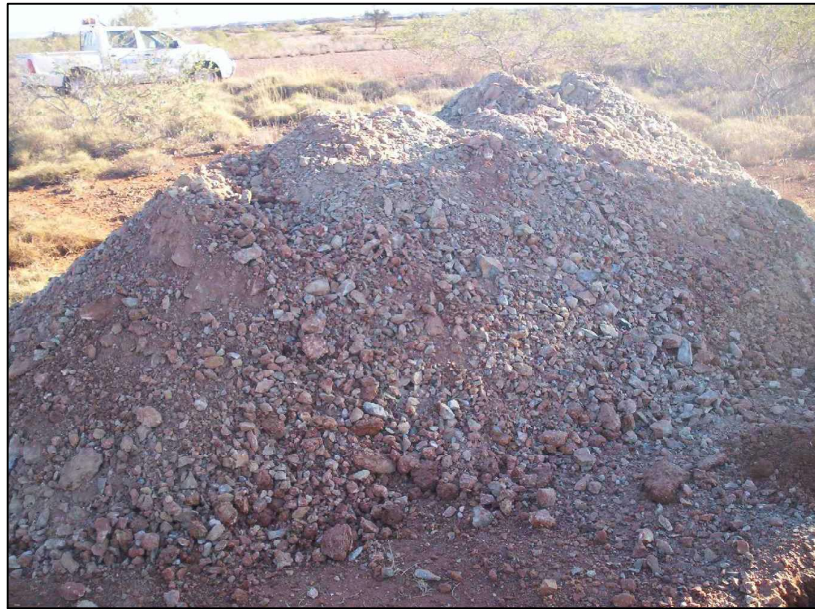
TP11.

TP11 - Stockpile.

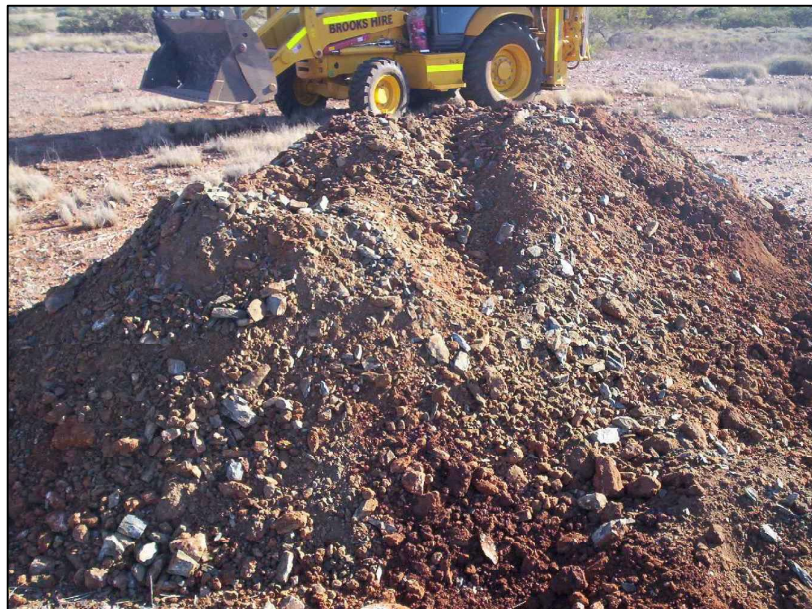
TP12 - Stockpile.

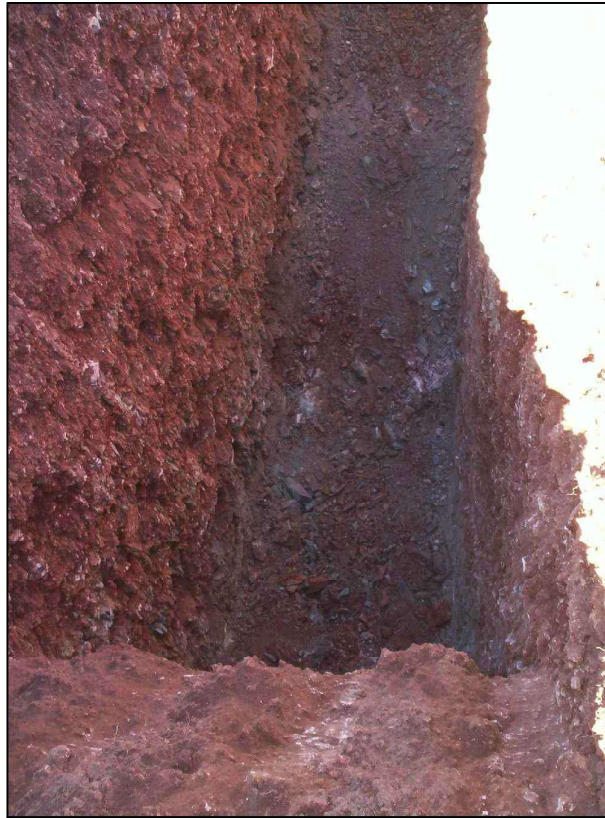
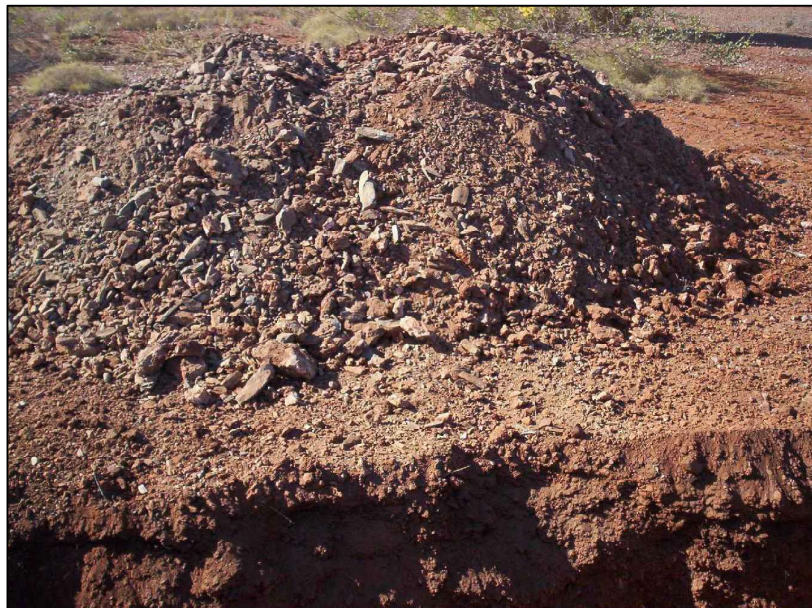
TP13.

TP13 - Stockpile.

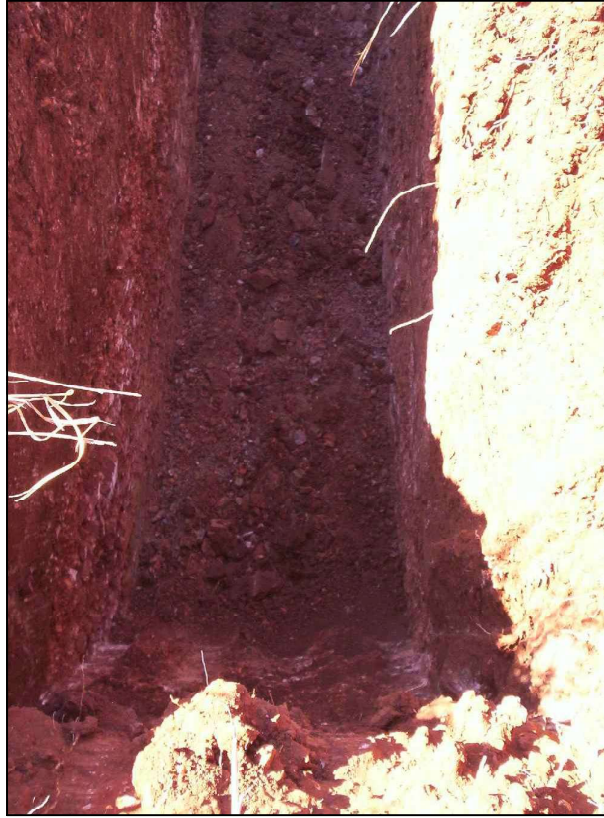
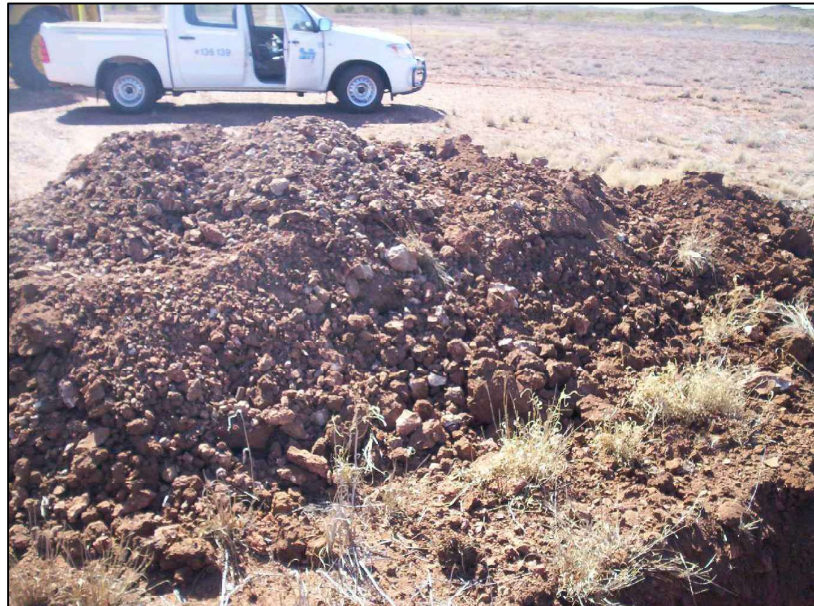
TP14.

TP14 - Stockpile.

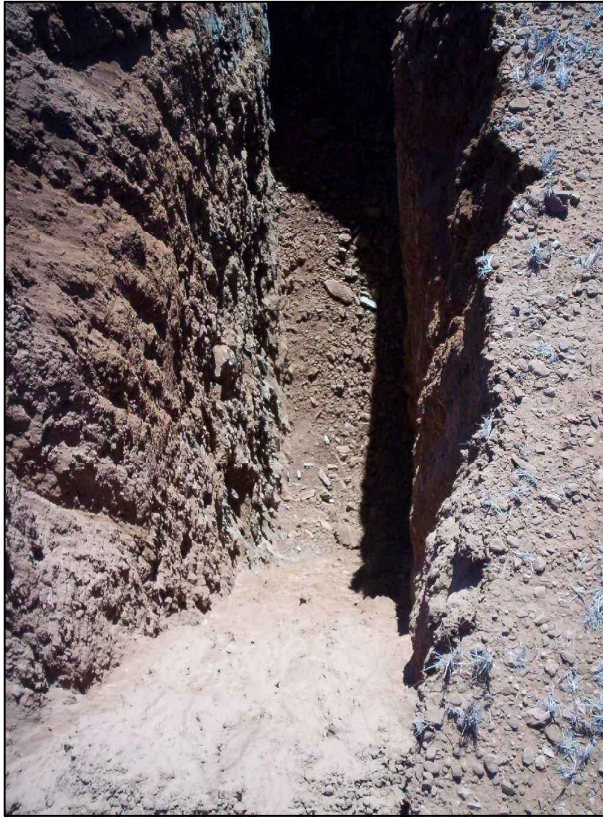
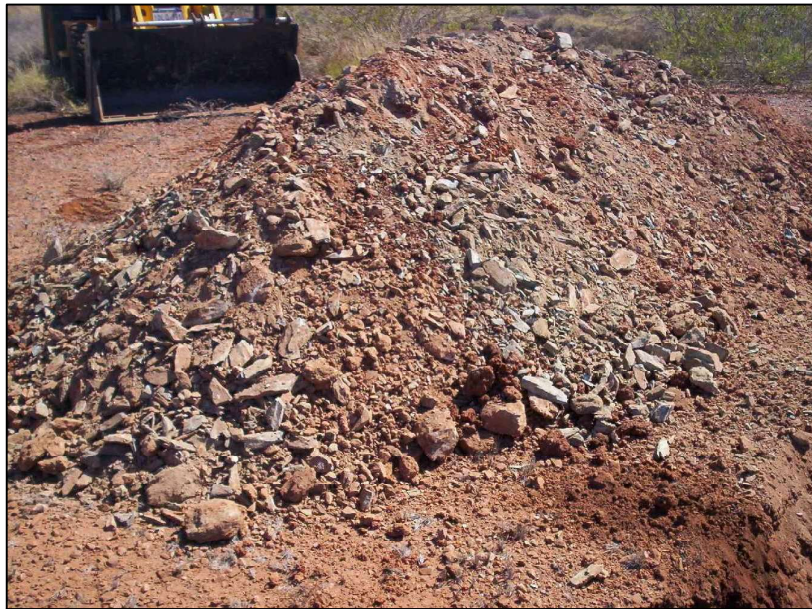
TP15.

TP15 - Stockpile.

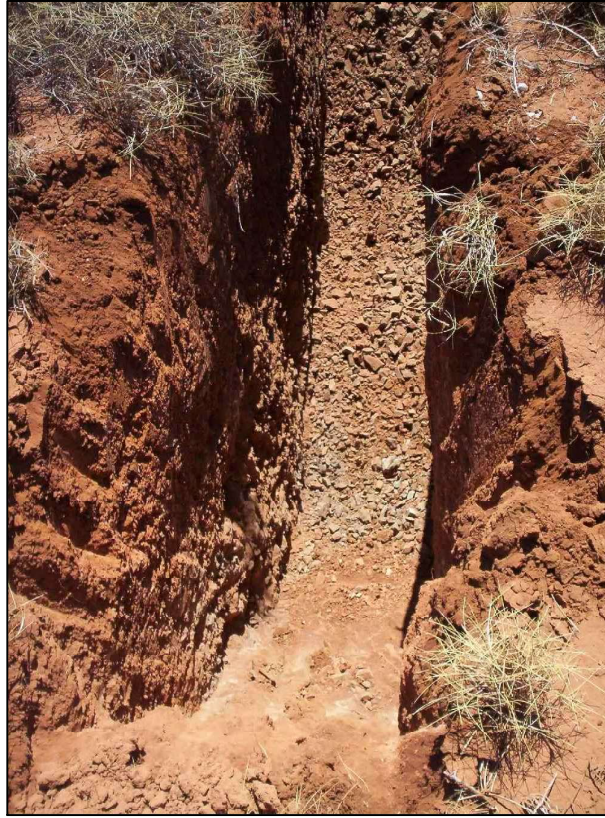
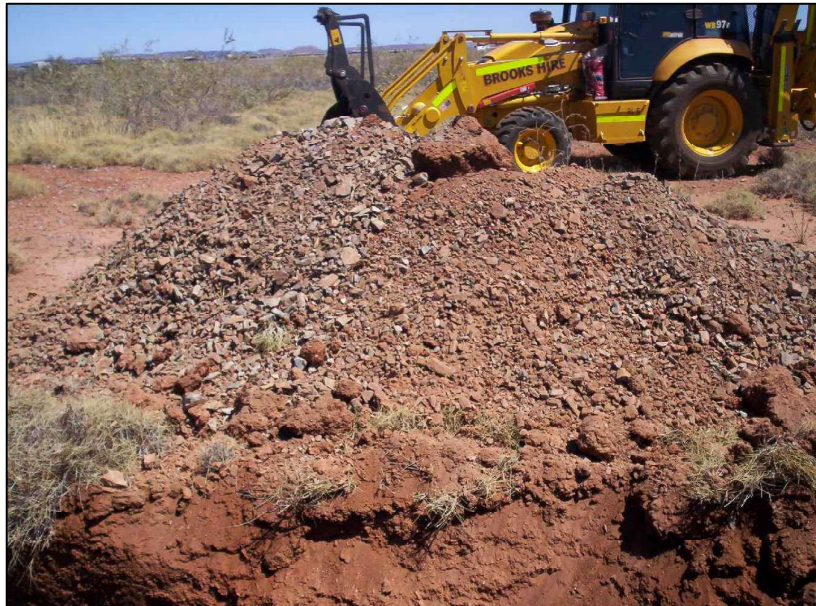
TP16.

TP16 - Stockpile.

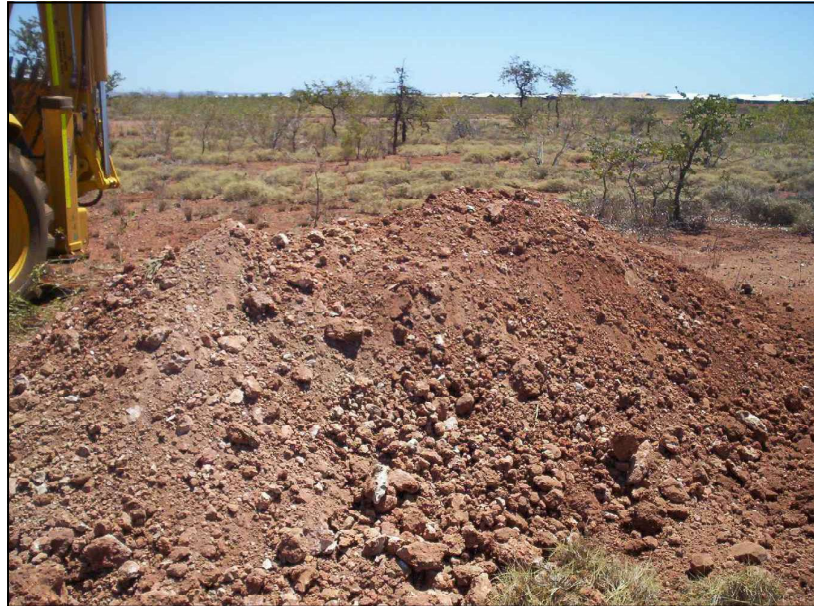
TP17 - Stockpile.

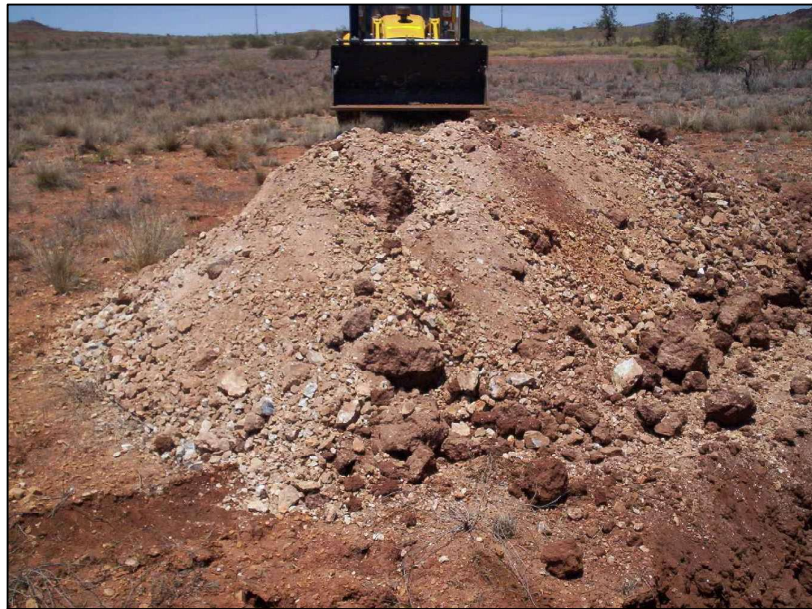
TP18 - Stockpile.

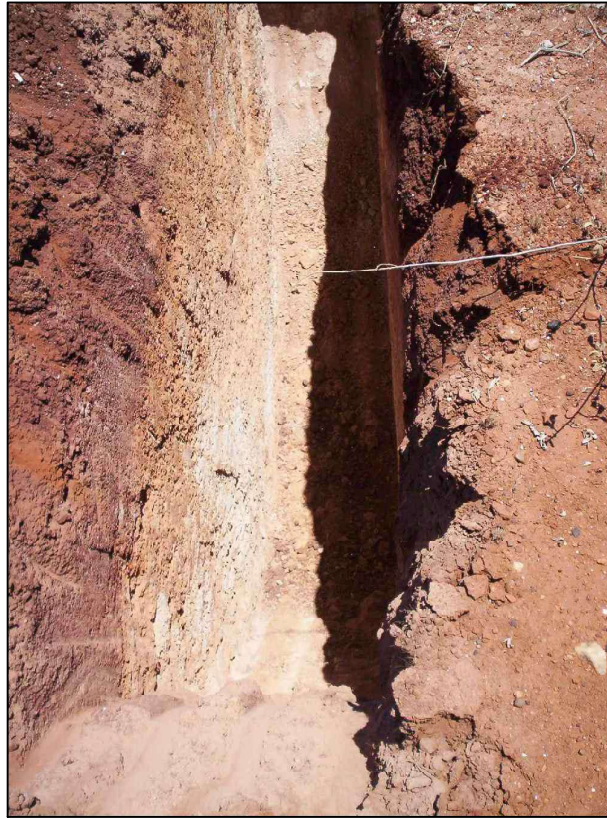
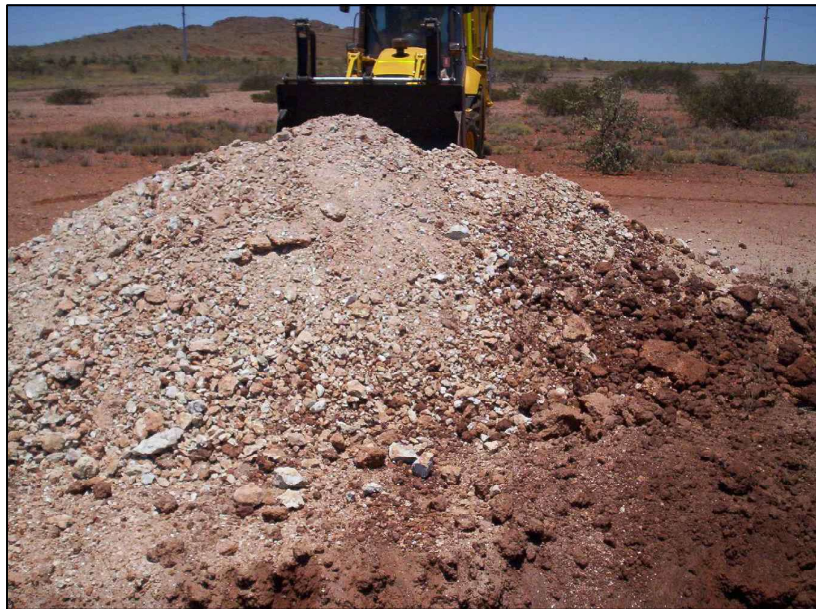
TP19.

TP19 - Stockpile.

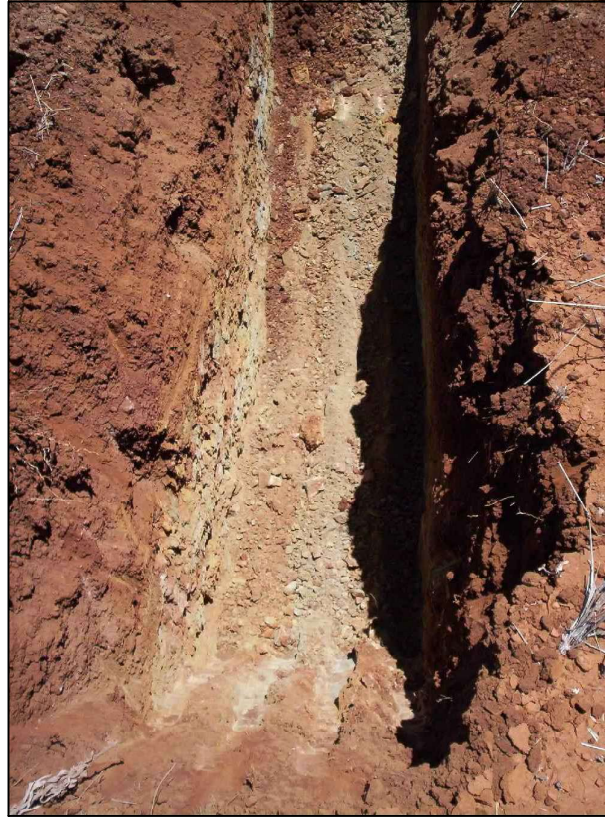
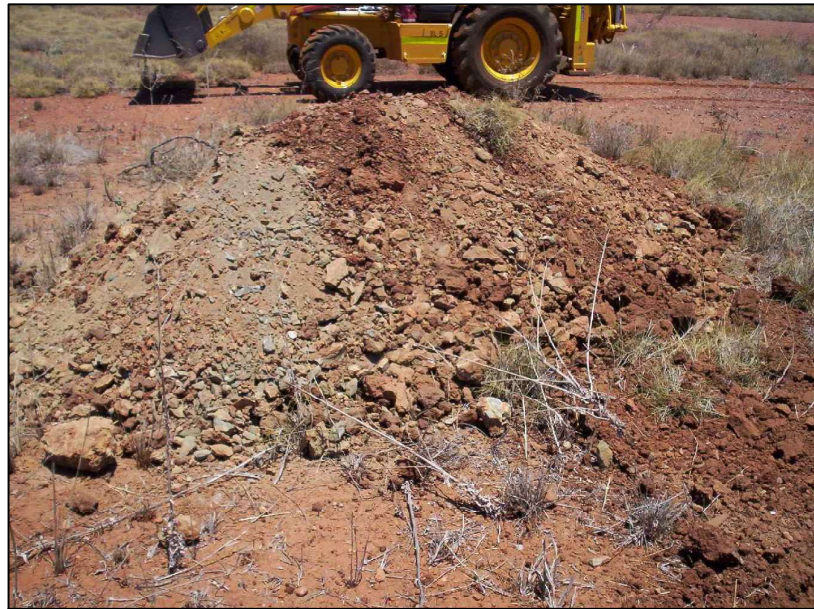
TP20.

TP20 - Stockpile.

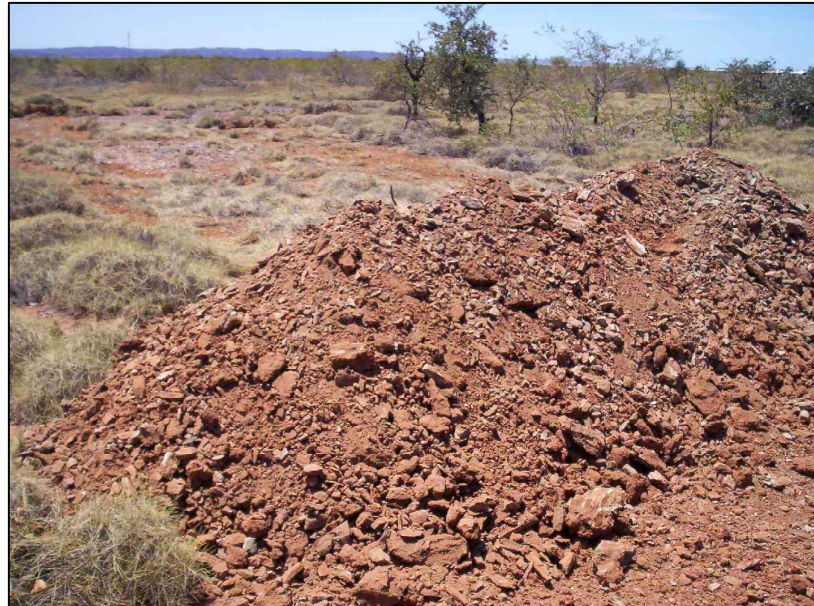
TP21.

TP21 - Stockpile.

drawn	LB		client:	COSSILL & WEBLEY CONSULTING ENGINEERS		
approved			project:	MADIGAN ROAD DEVELOPMENT SITE MADIGAN ROAD, KARRATHA		
date	3/11/10		title:	TEST PIT PHOTOGRAPHS - TP21		
scale	NOT TO SCALE		project no:	GEOTPERT02828AS	fig no:	
original size	A4				rev:

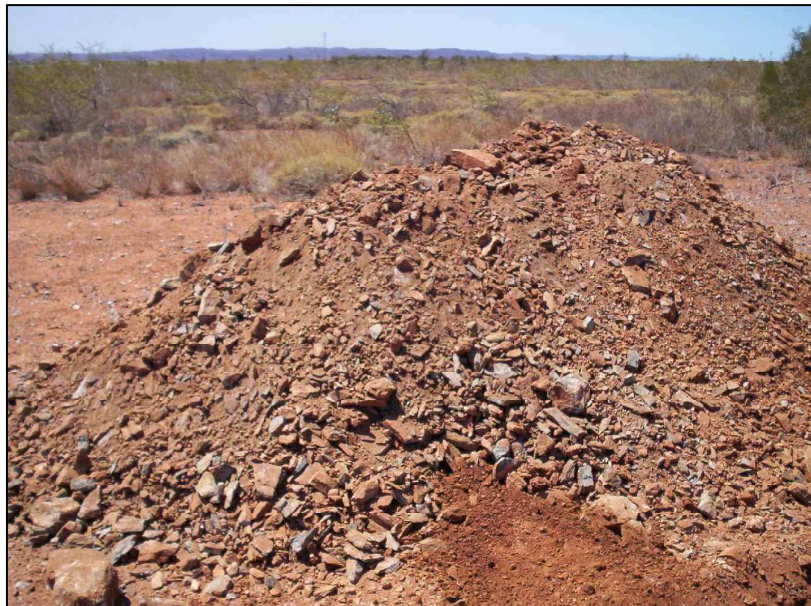
TP22.

TP22 - Stockpile.

drawn	LB		client:	COSSILL & WEBLEY CONSULTING ENGINEERS		
approved			project:	MADIGAN ROAD DEVELOPMENT SITE MADIGAN ROAD, KARRATHA		
date	3/11/10		title:	TEST PIT PHOTOGRAPHS - TP22		
scale	NOT TO SCALE		project no:	GEOTPERT02828AS	fig no:	
original size	A4		rev:

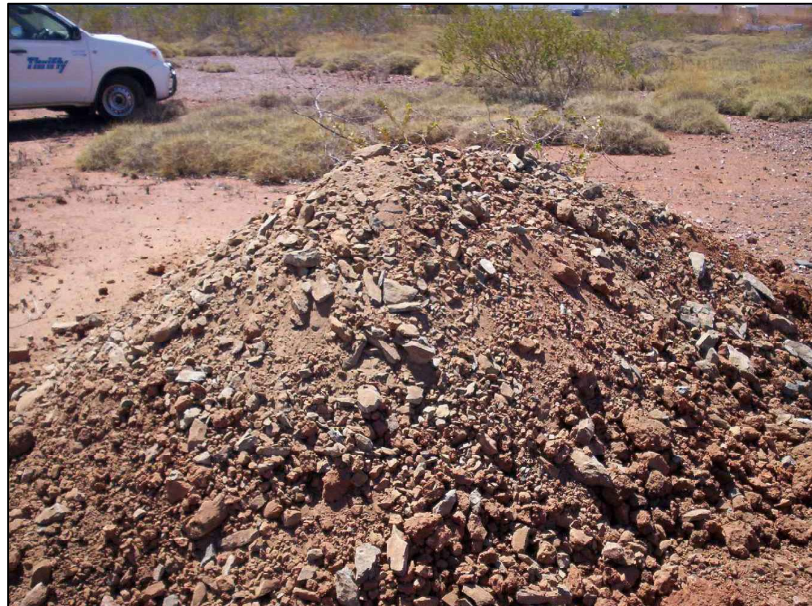
TP23.

TP23 - Stockpile.

drawn	LB		client:	COSSILL & WEBLEY CONSULTING ENGINEERS		
approved			project:	MADIGAN ROAD DEVELOPMENT SITE MADIGAN ROAD, KARRATHA		
date	3/11/10		title:	TEST PIT PHOTOGRAPHS - TP23		
scale	NOT TO SCALE		project no:	GEOTPERT02828AS	fig no:	
original size	A4		rev:

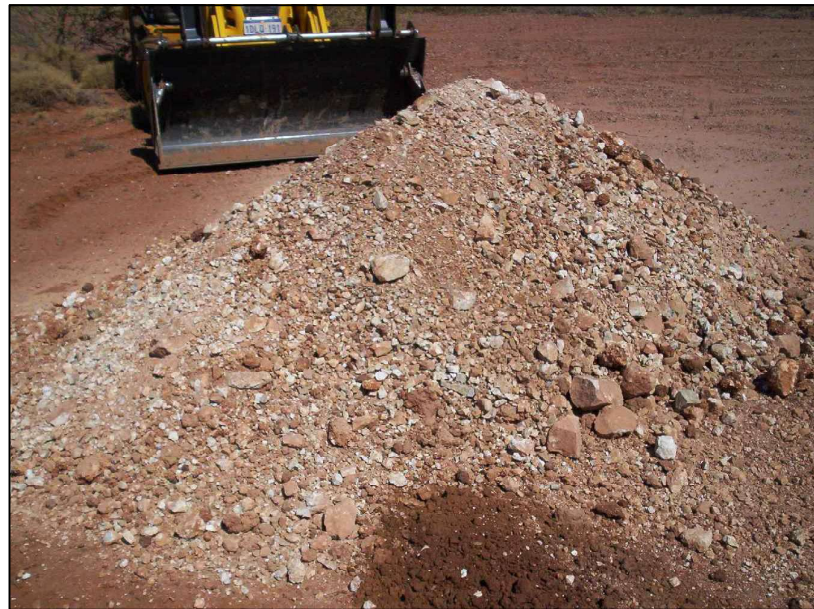
TP24.

TP24 - Stockpile.

drawn	LB		client:	COSSILL & WEBLEY CONSULTING ENGINEERS		
approved			project:	MADIGAN ROAD DEVELOPMENT SITE MADIGAN ROAD, KARRATHA		
date	3/11/10		title:	TEST PIT PHOTOGRAPHS - TP24		
scale	NOT TO SCALE		project no:	GEOTPERT02828AS	fig no:	
original size	A4				rev:

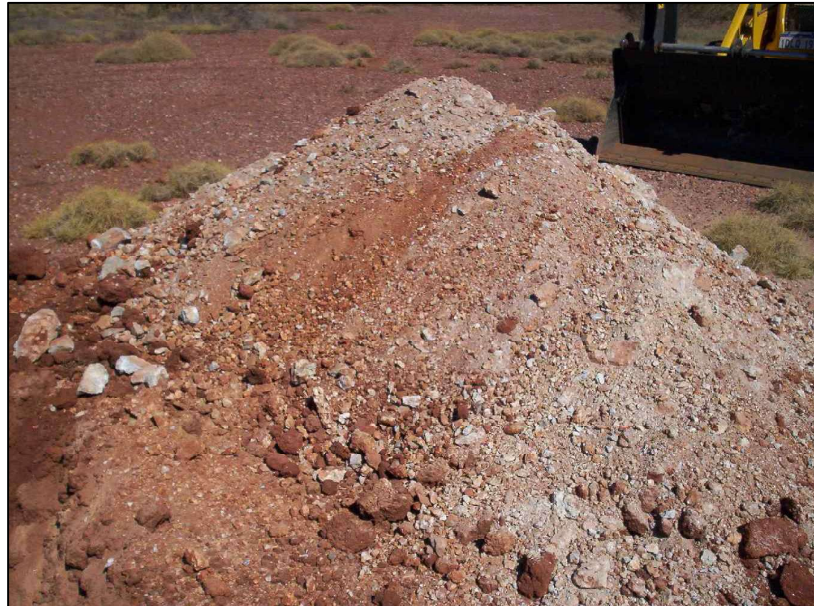
TP25.

TP25 - Stockpile.

<p>coffey geotechnics SPECIALISTS MANAGING THE EARTH</p>	client:	COSSILL & WEBLEY CONSULTING ENGINEERS		
approved			project:	MADIGAN ROAD DEVELOPMENT SITE MADIGAN ROAD, KARRATHA		
date	3/11/10		title:	TEST PIT PHOTOGRAPHS - TP25		
scale	NOT TO SCALE		project no:	GEOTPERT02828AS	fig no:	
original size	A4		rev:

Sample Number	Sample Identification	Moisture Content
WELS10S- 03820	TP25 @ 0.00 - 0.50m	3.3%

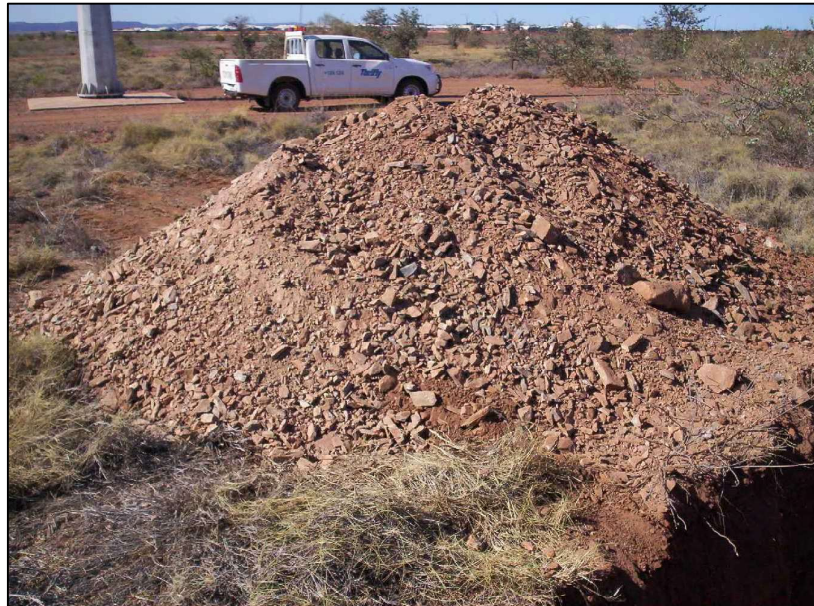
TP26.

TP26 - Stockpile.

drawn	LB		client:	COSSILL & WEBLEY CONSULTING ENGINEERS		
approved			project:	MADIGAN ROAD DEVELOPMENT SITE MADIGAN ROAD, KARRATHA		
date	3/11/10		title:	TEST PIT PHOTOGRAPHS - TP26		
scale	NOT TO SCALE		project no:	GEOTPERT02828AS	fig no:	
original size	A4		rev:

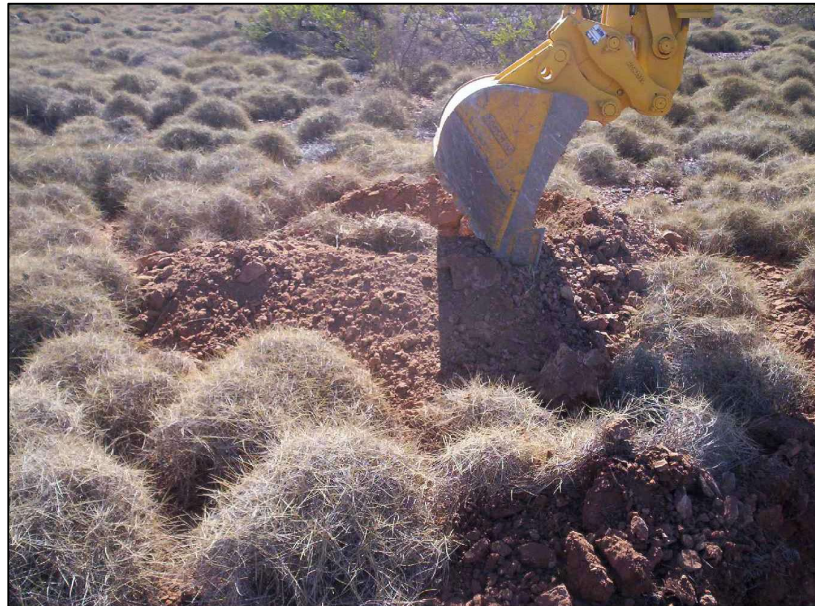
TP27.

TP27 - Stockpile.

drawn	LB		client:	COSSILL & WEBLEY CONSULTING ENGINEERS		
approved			project:	MADIGAN ROAD DEVELOPMENT SITE MADIGAN ROAD, KARRATHA		
date	3/11/10		title:	TEST PIT PHOTOGRAPHS - TP27		
scale	NOT TO SCALE		project no:	GEOTPERT02828AS	fig no:	
original size	A4				rev:

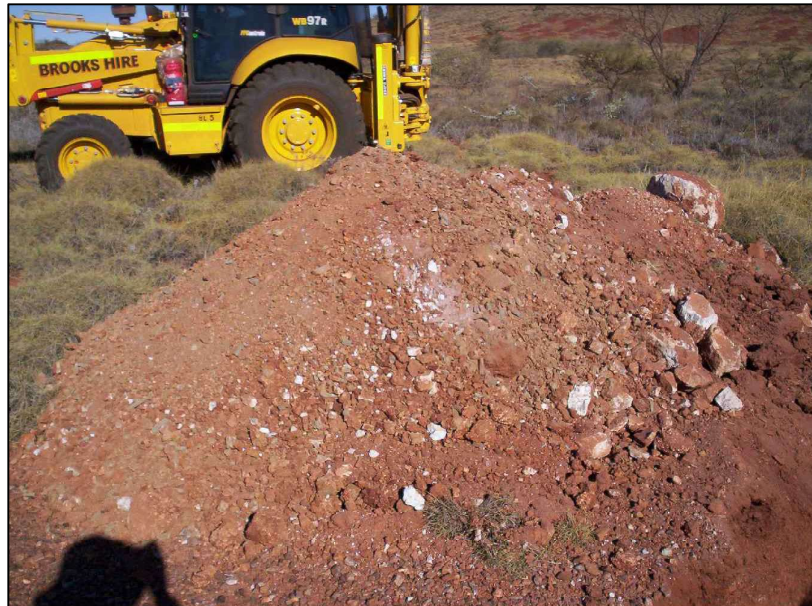
TP28.

TP28 - Stockpile.

drawn	LB		client:	COSSILL & WEBLEY CONSULTING ENGINEERS		
approved			project:	MADIGAN ROAD DEVELOPMENT SITE MADIGAN ROAD, KARRATHA		
date	3/11/10		title:	TEST PIT PHOTOGRAPHS - TP28		
scale	NOT TO SCALE		project no:	GEOTPERT02828AS	fig no:	
original size	A4				rev:

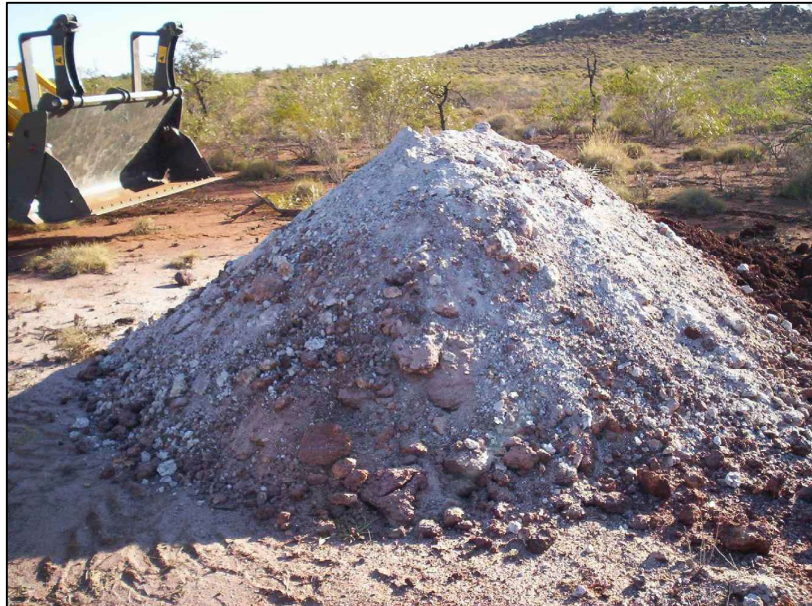
TP29.

TP29 - Stockpile.

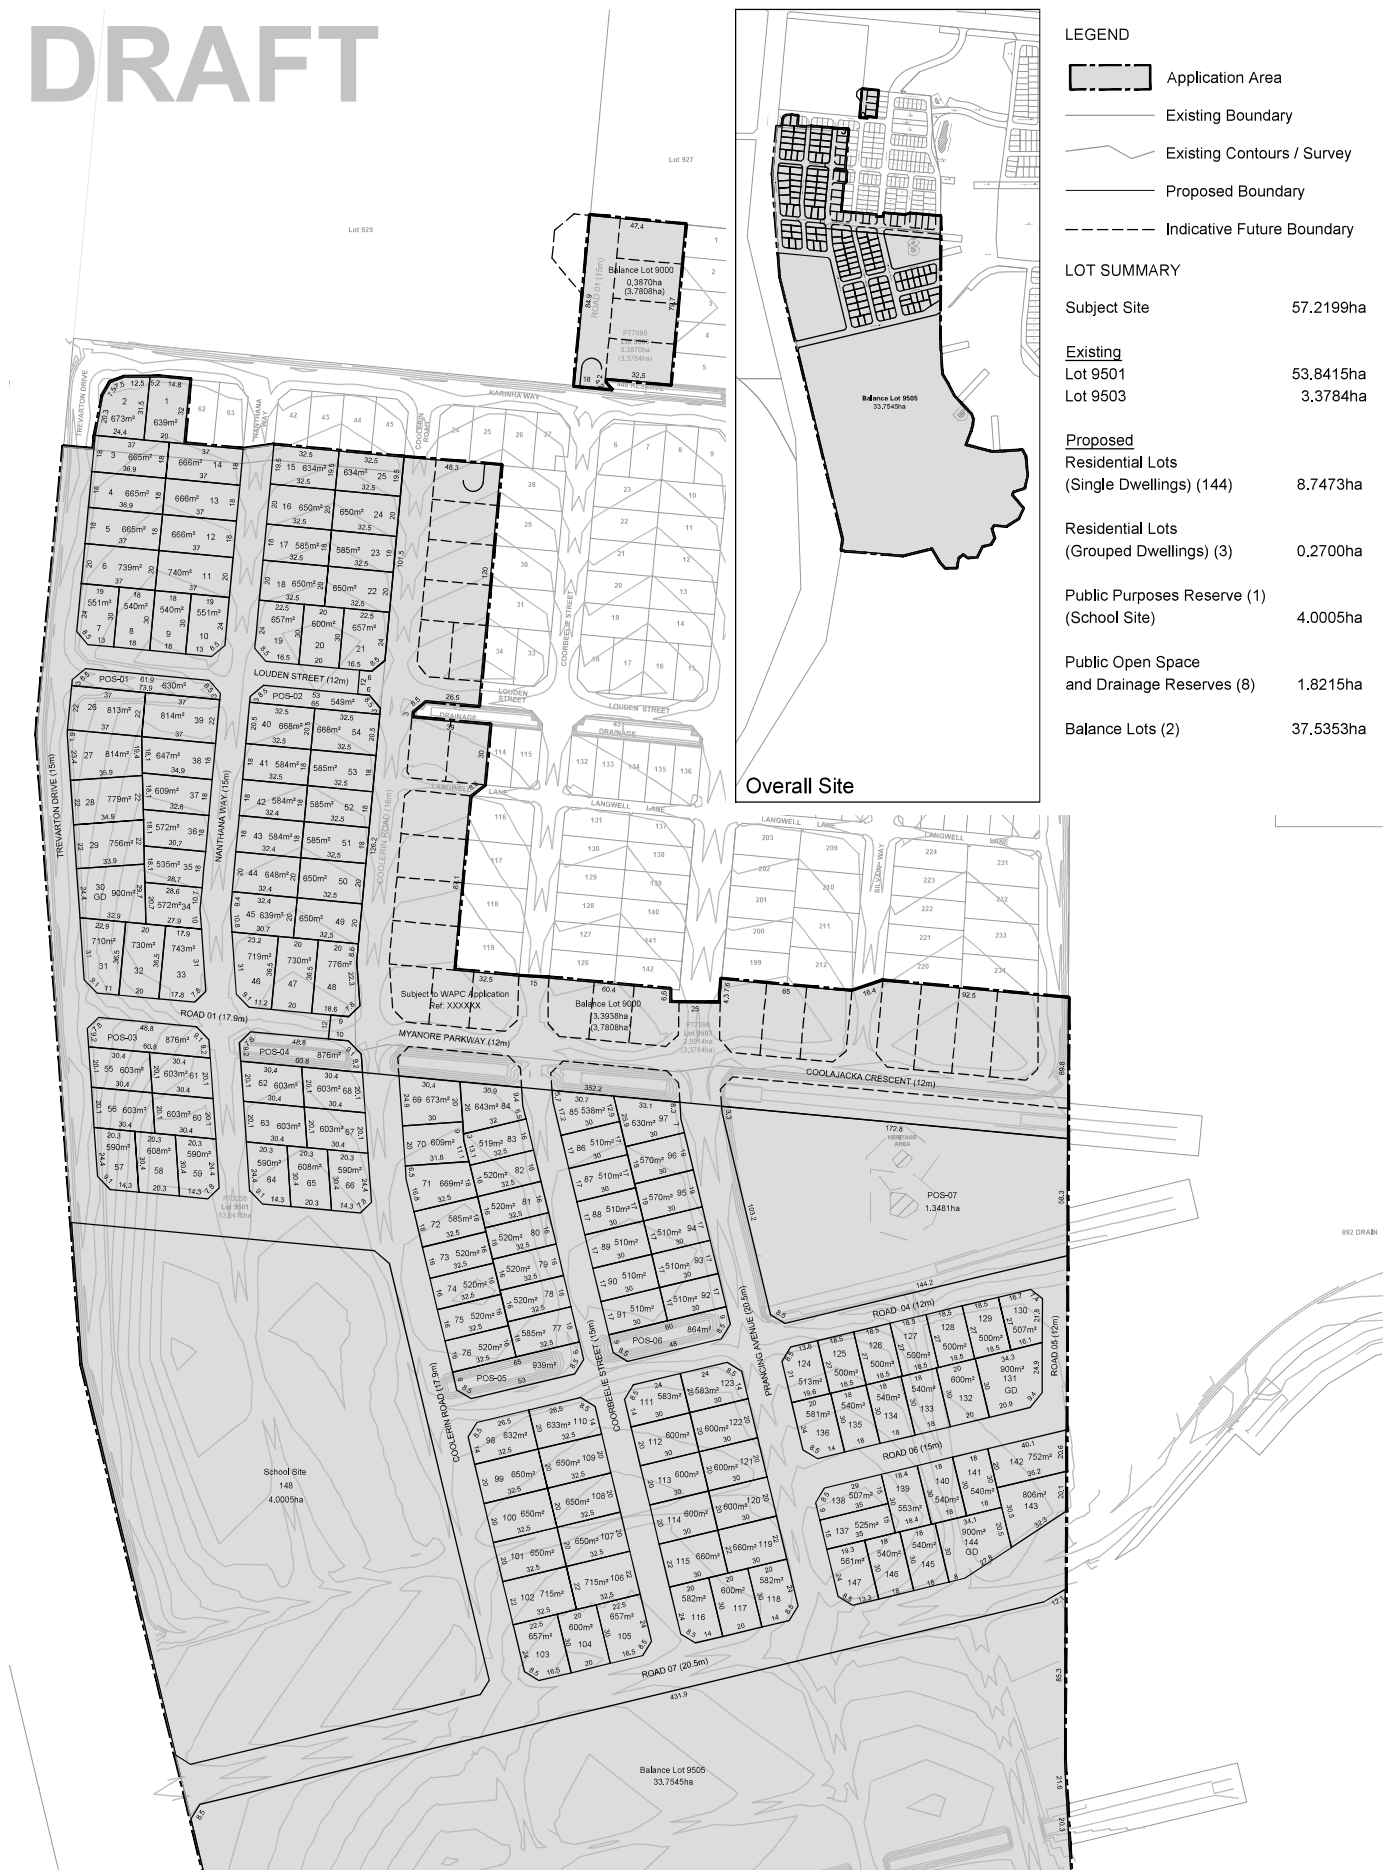
Subdivision Plan Madigan Road, Gap Ridge

Subject Site	57.2199ha
Existing	
Lot 9501	53,8415ha
Lot 9503	3.3784ha
Proposed	
Residential Lots (Single Dwellings) (144)	8.7473ha
Residential Lots (Grouped Dwellings) (3)	0.2700ha
Public Purposes Reserve (1) (School Site)	4.0005ha
Public Open Space and Drainage Reserves (8)	1.8215ha
Balance Lots (2)	37.5353ha

Date: 27 Oct 2020 Scale: 1:2500 @ A3 1:1250 @ A1 File: 19-314 SU02A Staff: MR MD GW Checked: MD
