Bayview Road Culvert Replacement

Projects and Infrastructure

8 December 2025

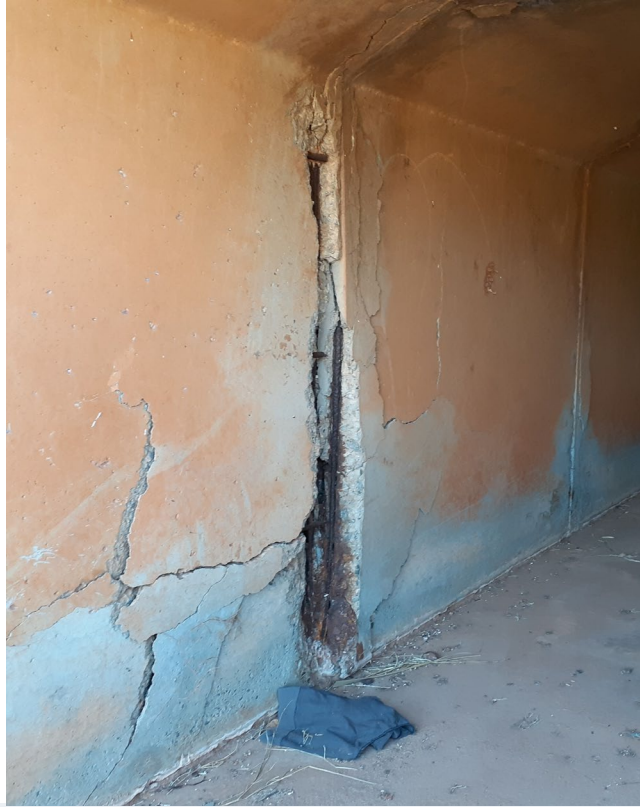
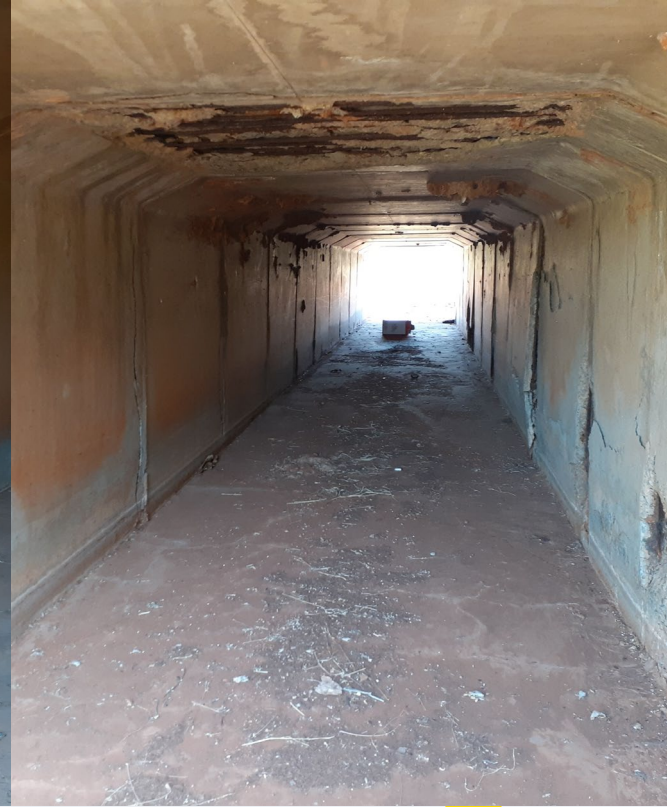
Current Condition

- Two-barrel box culvert
- 40+ Years old
- Cracking
- Exposed reo-bar
- Extensive spalling

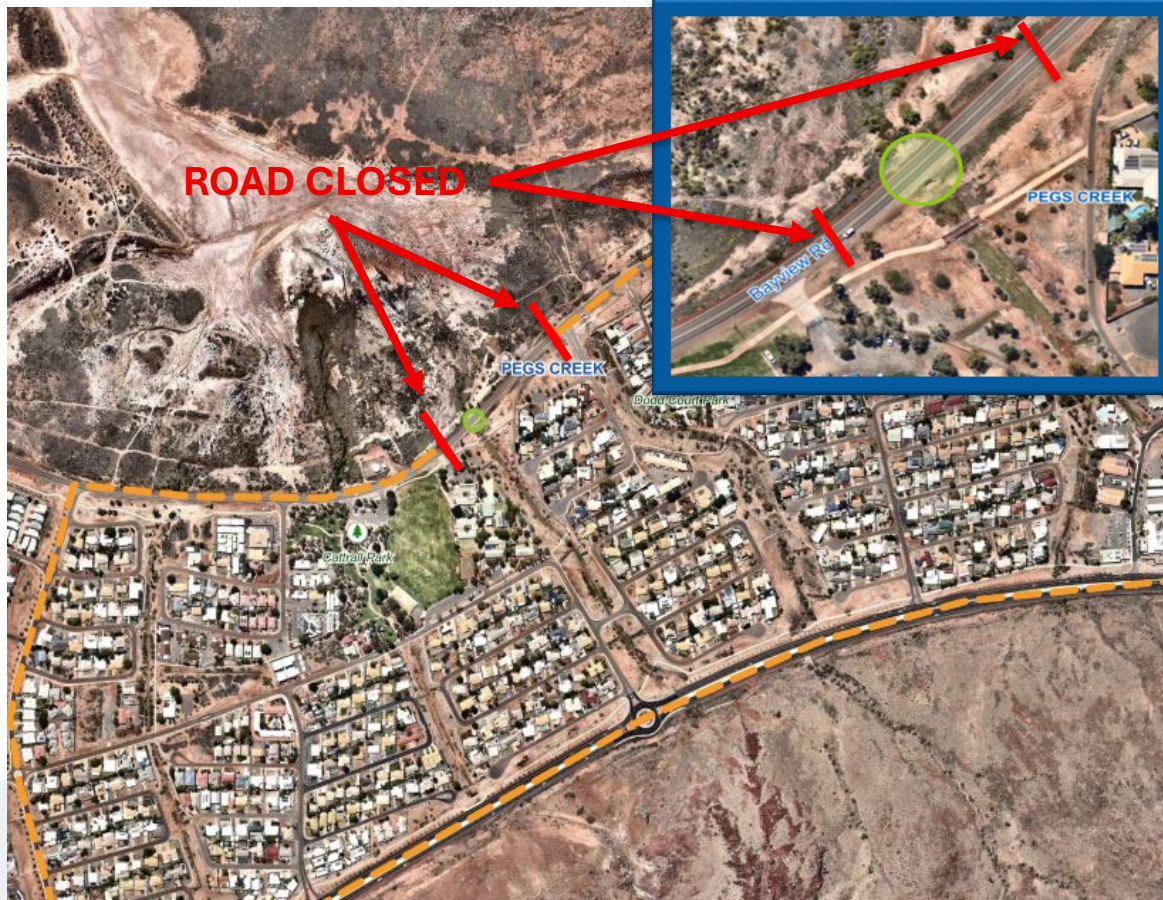
- Location
 - Central Pegs Creek drainage line
 - Construction constraints: Narrow road
- Traffic Management
 - 6 weeks Road Closure
 - Detours via Dampier Road
- Community Impact Mitigation
 - Early communications
 - Clear and consistent messaging

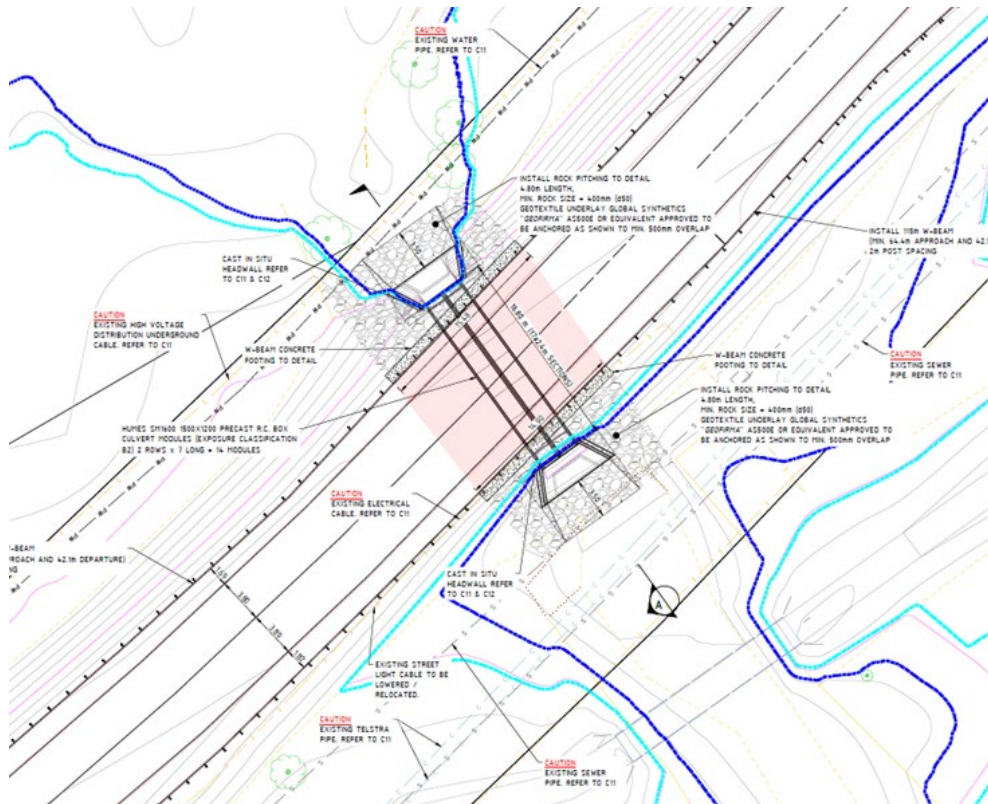
Design and OPC

- Cost Estimate: \$1.8M (+/- 30%)
- Design includes:
 - Two-barrel box culverts
 - W-beam guardrails
 - Service relocation
 - Road Re-instatement
 - Traffic Management
